Comprehensive Energy Audit For Grayling WTP

Prepared For
City Of Grayling

July 29, 2014

**ANTHC-DEHE
3900 Ambassador Drive, Suite 301
Anchorage, AK 99508**

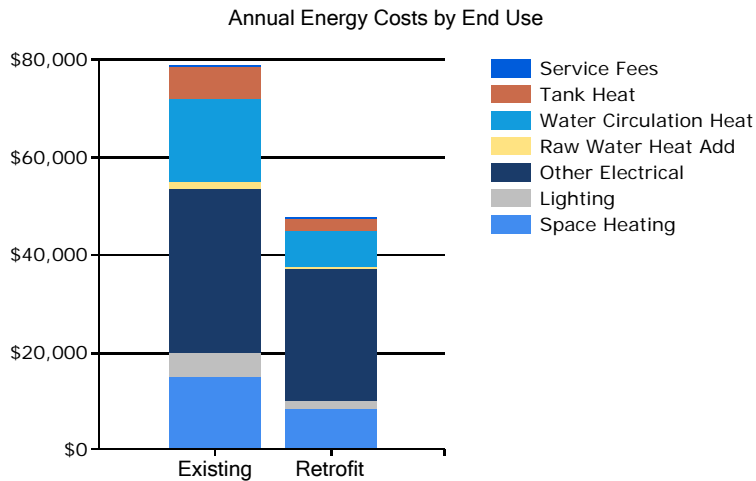
Figure 3.1
Annual Energy Costs by End Use

Figure 3.1 below reflects the estimated distribution of costs across the primary end uses of energy based on the AkWarm© computer simulation. Comparing the “Retrofit” bar in the figure to the “Existing” bar shows the potential savings from implementing all of the energy efficiency measures shown in this report.

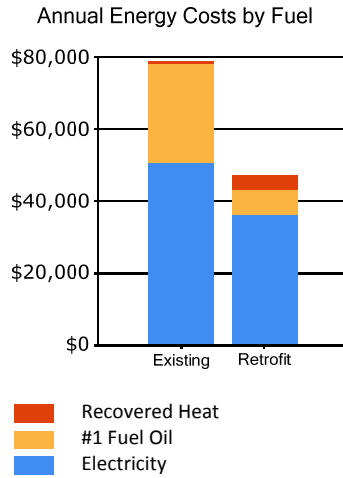
Figure 3.2
Annual Energy Costs by Fuel Type

Figure 3.2 below shows how the annual energy cost of the building splits between the different fuels used by the building. The “Existing” bar shows the breakdown for the building as it is now; the “Retrofit” bar shows the predicted costs if all of the energy efficiency measures in this report are implemented.

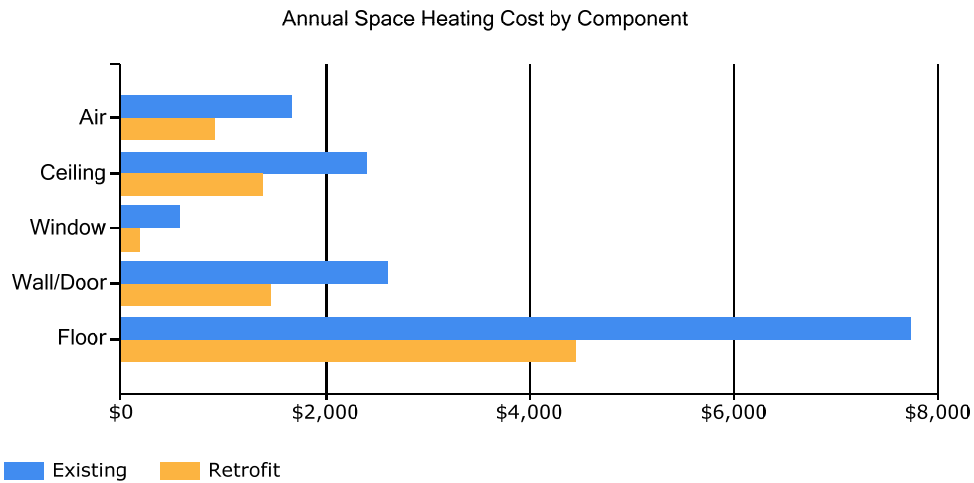
Figure 3.3
Annual Space Heating Cost by Component

Figure 3.3 below addresses only Space Heating costs. The figure shows how each heat loss component contributes to those costs; for example, the figure shows how much annual space heating cost is caused by the heat loss through the Walls/Doors. For each component, the space heating cost for the Existing building is shown (blue bar) and the space heating cost assuming all retrofits are implemented (yellow bar) are shown.

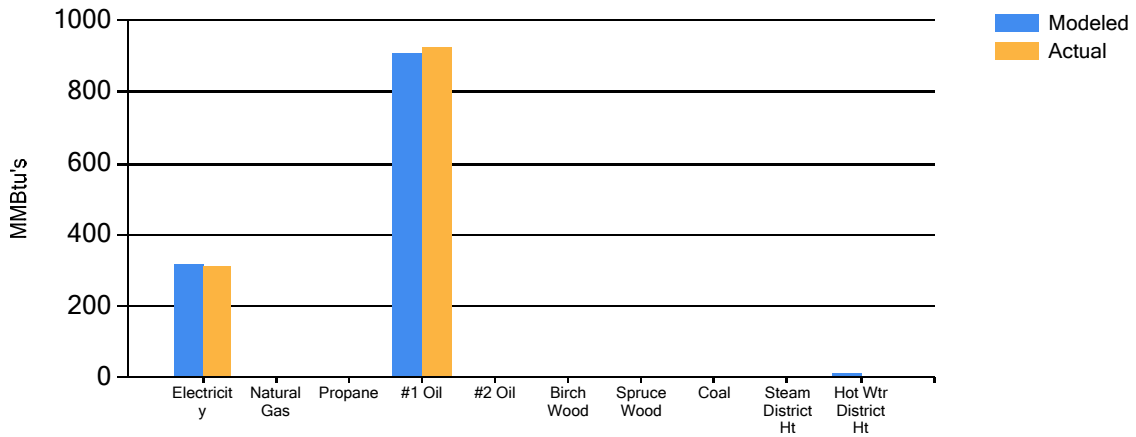
Annual Fuel Use

The Orange bars show Actual fuel use, and the Blue bars are AkWarm’s prediction of fuel use.
