# Comprehensive Energy Audit For Kotzebue Water Treatment Plant

Prepared For  
**City Of Kotzebue**

**May 11, 2016**

**ANTHC-DEHE  
4500 Diplomacy Dr, Suite 454  
Anchorage, AK 99508**

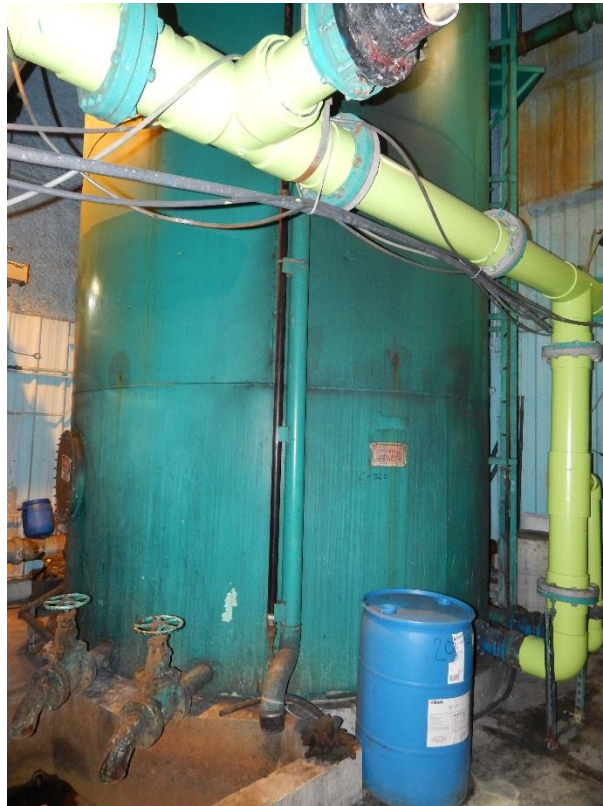
Figure 1: Surge Tank used for mixing Aluminum Sulfate Hydrate into the water.

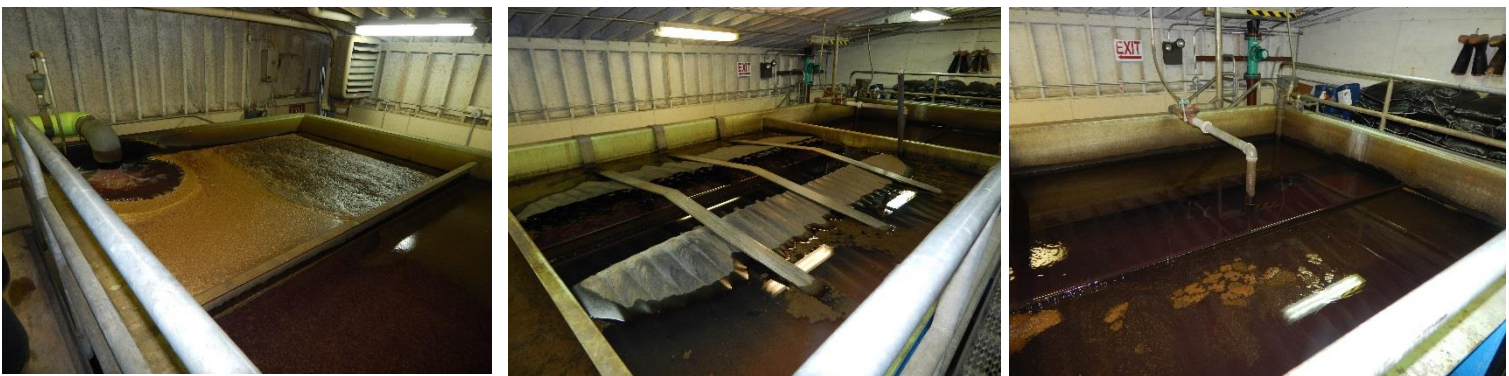
After the water exits the surge tank, it is pumped into two large open-roofed filter tanks that process all the treated water before sending it to the distribution loops.

Figure 2: Three photos showing one of two open filter process tanks.

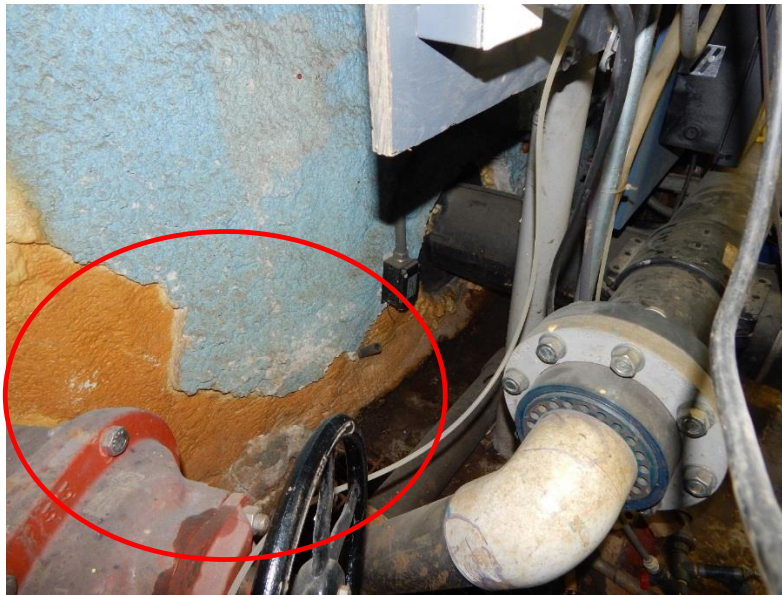
The exterior walls are constructed with 2x10 standard lumber with 16-inch spacing. Insulation throughout the building is very damaged with many pieces missing or falling off, water damage, and deterioration of the insulation after decades of exposure to the open air environment. Also, different sections of the building have variable amounts of wall insulation depending on when that section of the water treatment plant building was constructed. Details of the insulation damage can be seen in Figures 3,4, and 5. There is a total of approximately 5,835 square feet of wall space in the building. Of this total, approximately 1,517 square feet has 3.5 inches of polyurethane foam insulation, 2,859 square feet has 5.5 inches of polyurethane foam insulation, and 1,459 square feet has 6 inches of fiberglass batt insulation.

**Figure 3: Insulation damage on the wall near the water storage tank wall penetrations.**

Rank	Location	Existing Type/R-Value			Recommendation Type/R-Value	
15	Above-Grade Wall: WTP Walls 6 Inch Batt	Wall Type: Single Stud Siding Configuration: Siding and Sheathing Insul. Sheathing: None Structural Wall: 2 x 10, 16 inches on center R-11 Batt:FG or RW, 3.5 inches Window and door headers: Not Insulated Insulation Quality: Very Damaged Modeled R-Value: 9.5			Remove old insulation and install R-21 fiberglass batts in 2x6 wall.	
Installation Cost		\$8,930	Estimated Life of Measure (yrs)	30	Energy Savings (/yr)	\$835
Breakeven Cost		\$19,358	Savings-to-Investment Ratio	2.2	Simple Payback yrs	11
Auditors Notes: The building insulation is aging, damaged, and does not provide adequate insulation for the winter conditions. Replace the existing insulation with 10 inches of R-21 fiberglass batt insulation with a proper inner wall cover.

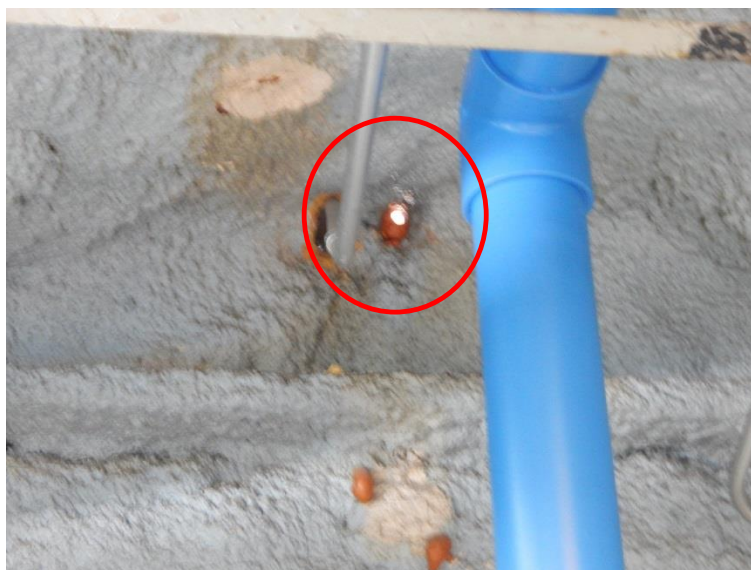
**Figure 4: Visible holes in the wall insulation where air can leak directly to the outside.**

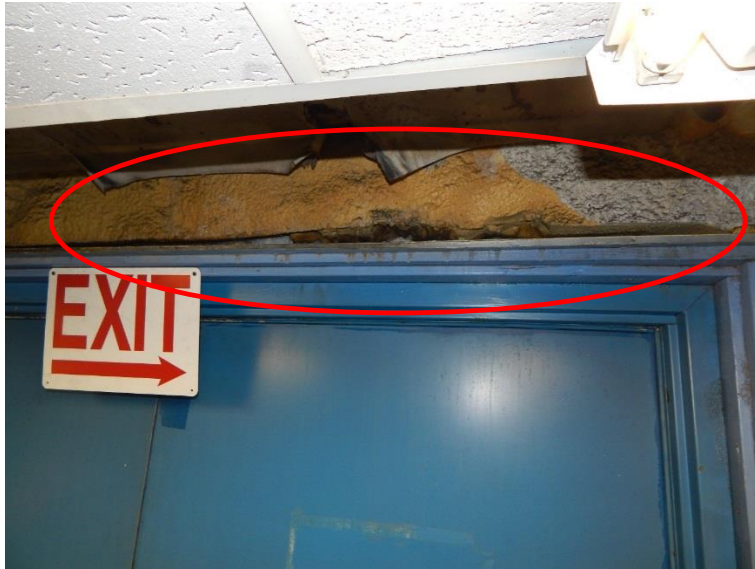
**Figure 5: Insulation damage along the door seam by the process room doors.**

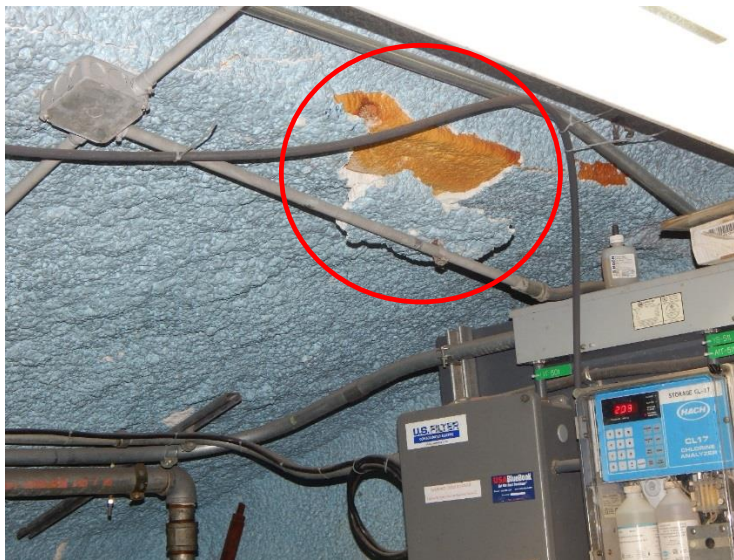
The building has cathedral ceilings with multiple sections where the building was expanded. There is a total of approximately 6,585 square feet of ceiling space in the building. Of this total, approximately 1,251 square feet has 3.5 inches of polyurethane foam insulation, 2,041 square feet has 5.5 inches of polyurethane foam insulation, and 3,293 square feet has 6 inches of fiberglass batt insulation. The insulation throughout the entire building is very damaged with signs of missing pieces, broken chunks, and water damage. This damage is shown in Figures 6 and 7.

**Figure 6: Pieces of insulation are falling off from the ceiling by the raw water intake.**

Rank	Location	Existing Type/R-Value		Recommendation Type/R-Value		
14	Cathedral Ceiling: WTP Roof 3.5 Inch Foam	Framing Type: Standard Framing Spacing: 24 inches Insulated Sheathing: None Bottom Insulation Layer: Polyurethane (PLUR), 2 inches Top Insulation Layer: None Insulation Quality: Very Damaged Modeled R-Value: 10		Remove insulation in 2x6 cavity and replace with R-21 fiberglass batts		
Installation Cost		\$10,224	Estimated Life of Measure (yrs)	30	Energy Savings (/yr)	\$1,053
Breakeven Cost		\$24,383	Savings-to-Investment Ratio	2.4	Simple Payback yrs	10
Auditors Notes: The building insulation is aging, damaged, and does not provide adequate insulation for the winter conditions. Replace the existing insulation with 10 inches of R-21 fiberglass batt insulation with a proper inner cover.

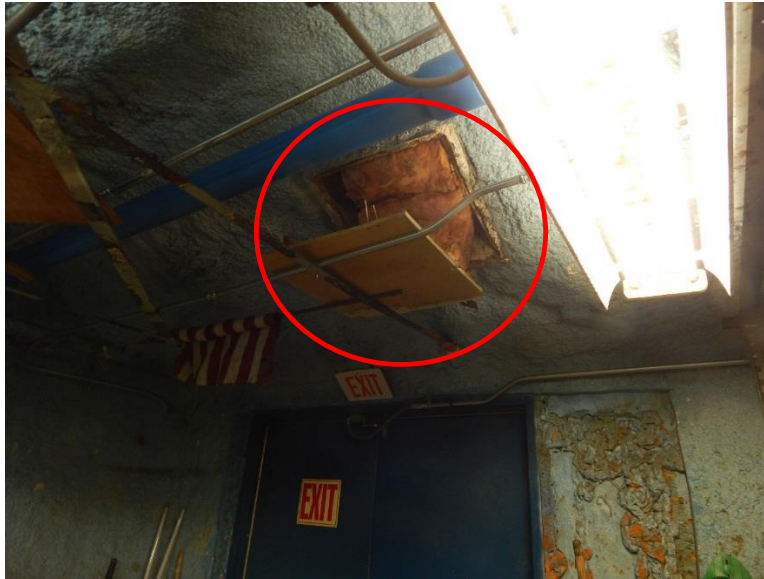
**Figure 7: A panel of insulation is falling through the ceiling of the building.**

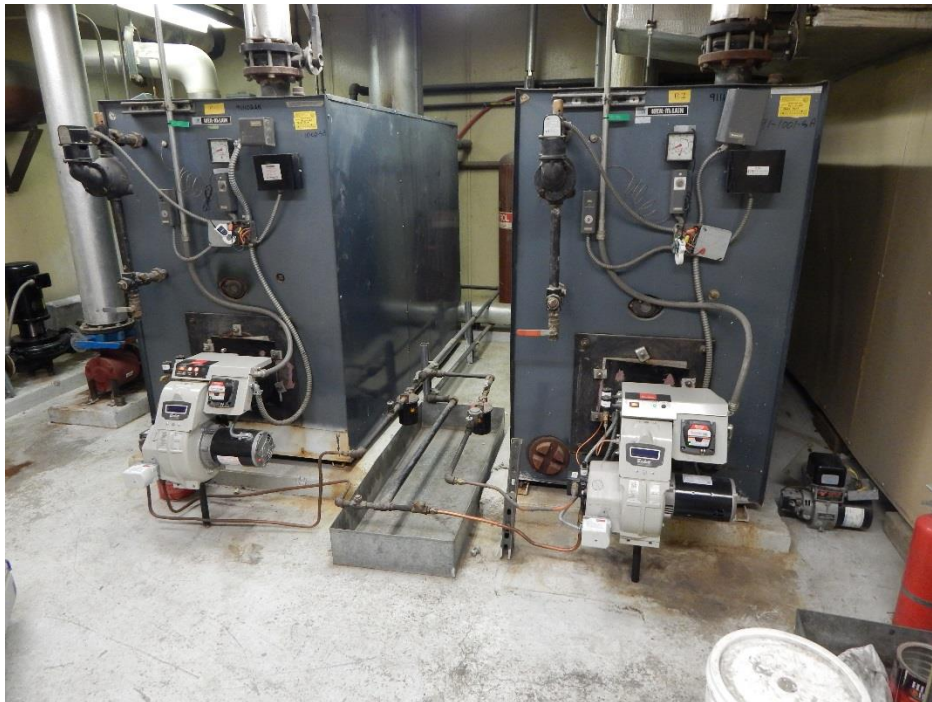
Fuel Type:	#1 Oil
Input Rating:	1,600,000 BTU/hr
Steady State Efficiency:	78 % (approximate)
Idle Loss:	2 %
Heat Distribution Type:	Glycol
Boiler Operation:	All Year
Notes:	1999 Vintage with Beckett Model CF2300A 2 stage burners. This Boiler operates approximately 14.9% of the time.

Steady State Efficiency:	78 % (approximate)
Idle Loss:	2 %
Heat Distribution Type:	Glycol
Boiler Operation:	All Year
Notes:	1999 Vintage with Beckett Model CF2300A 2 stage burners. This boiler operates approximately 13.3% of the time.

The two boilers are used for all space heating applications in the building. Additionally, while all of the water loops have heat-add systems, every loop heat-add is valved off such that there is no direct heat-add to the water in the entire plant. Instead, the water is heated through open-air exposure in the surge tank and filters, where unit heaters are operating continuously to meet the 70 deg. F set point. The unit heaters are unable to reach the set point because of the large mass of cold water, causing the heaters to run continuously. Due to the exposure of the water to the convective heating from the unit heaters, the water temperature is effectively raised during the filtration process by approximately 2 deg. F.

Figure 9: Weil McLain boilers in the boiler room. These boilers are used for the space heating in the building.

Rank	Recommendation				
21	Reduce boiler sizes to match current water treatment plant load. Convert generator heating from electric to fuel oil by installing a small heat exchanger and pump along with a small pipe to circulate glycol from the engine to the heat exchanger. The heat exchanger would tie in to the existing building circulation heat.				
<b>Installation Cost</b>	\$150,000	<b>Estimated Life of Measure (yrs)</b>	20	<b>Energy Savings (/yr)</b>	\$14,785
<b>Breakeven Cost</b>	\$239,167	<b>Savings-to-Investment Ratio</b>	1.6	<b>Simple Payback yrs</b>	10
Auditors Notes: The current boilers are oversized and rarely used to half capacity at any given time. Replace both boilers with smaller models rated at approximately 800 MBH to reduce the heating fuel requirement of the boilers. Also, install a heated glycol line from the current heating distribution loop to the generator such that the generator may use the glycol line for preheating rather than the electric heating unit currently used. Keep the electric heating unit as a backup system. Finally, replace the two solenoid valves within the building to insure optimum operations of the plant.

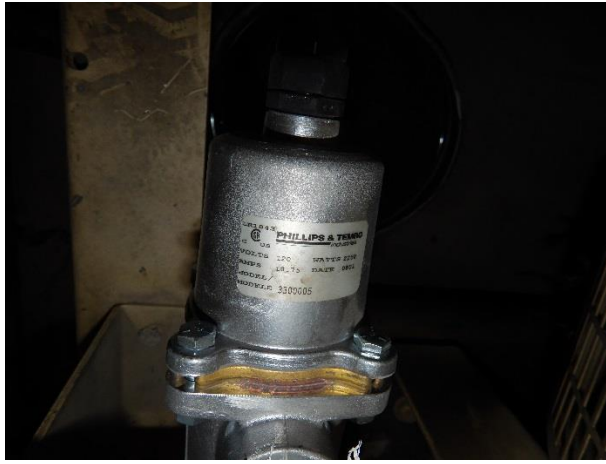
Fuel Type:	Electricity
Input Rating:	2250 Watts/hour
Steady State Efficiency:	100 %
Idle Loss:	0 %
Heat Distribution Type:	Glycol
Boiler Operation:	All Year

**Figure 10: Generator Block Heater**

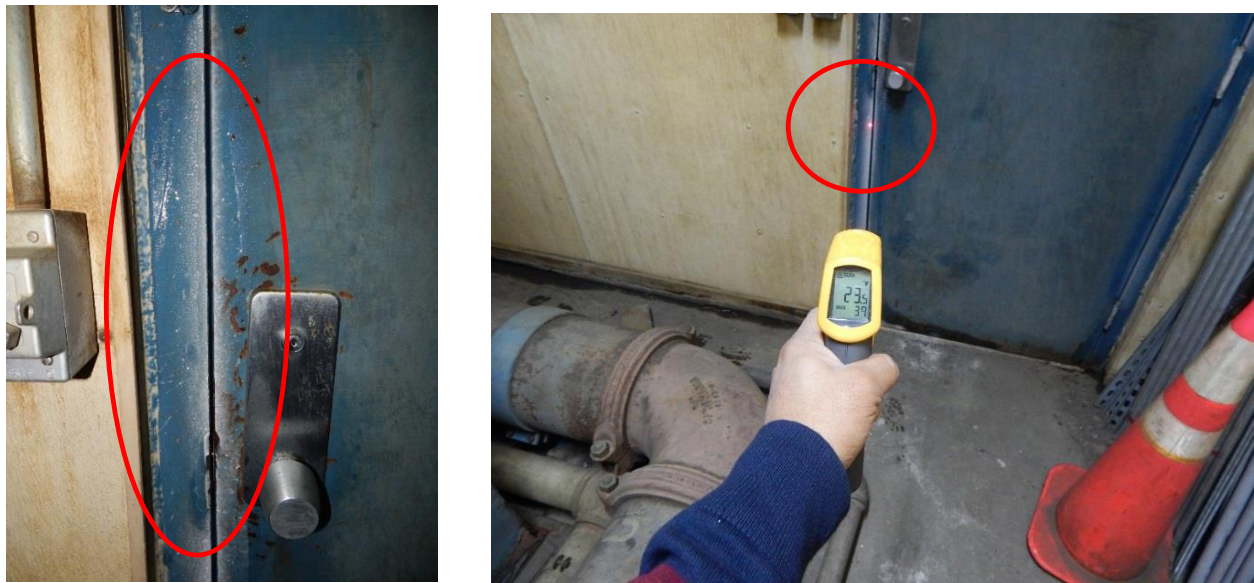
Unit Heater 14: 125 MBH rating, Filter Room by exit corner, operates continuously to meet the heating demand due to the presence of the large volume of water in the two filters with no cover.

Figure 11: Two photos showing the filtration room door seam with ice buildup due to the humidity from the filters. As a result of poor insulation and excessive air infiltration, the temperature at the door seam was 23 deg. F.

Rank	Location	Existing Air Leakage Level (cfm@50/75 Pa)		Recommended Air Leakage Reduction (cfm@50/75 Pa)		
13	Exterior man and garage doors	Air Tightness estimated as: 10000 cfm at 50 Pascals		Perform air sealing to reduce air leakage by 33%.		
Installation Cost		\$20,000	Estimated Life of Measure (yrs)	10	Energy Savings (/yr)	\$5,464
Breakeven Cost		\$50,222	Savings-to-Investment Ratio	2.5	Simple Payback yrs	4
Auditors Notes: Add weather stripping and close the gaps in the main entrance and garage doors to prevent air leakage from entering the building. This will save on maintenance by reducing the moisture content inside the building and will reduce the heating demand by keeping the cold air outside of the building.

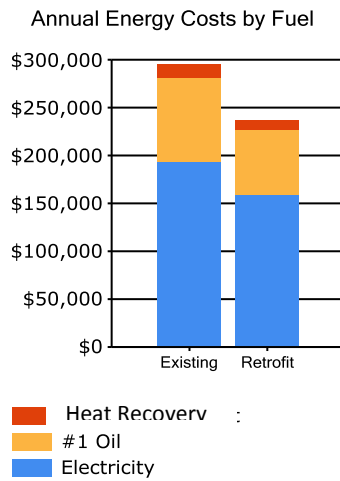
Figure 13 below shows how the annual energy cost of the building splits between the different fuels used by the building. The “Existing” bar shows the breakdown for the building as it is now; the “Retrofit” bar shows the predicted costs if all of the energy efficiency measures in this report are implemented.

**Figure 13: Annual Energy Costs by Fuel Type**
