# Comprehensive Energy Audit For Lime Village Washeteria

**Lime Village Traditional Council**

**August 5, 2016**

**ANTHC**

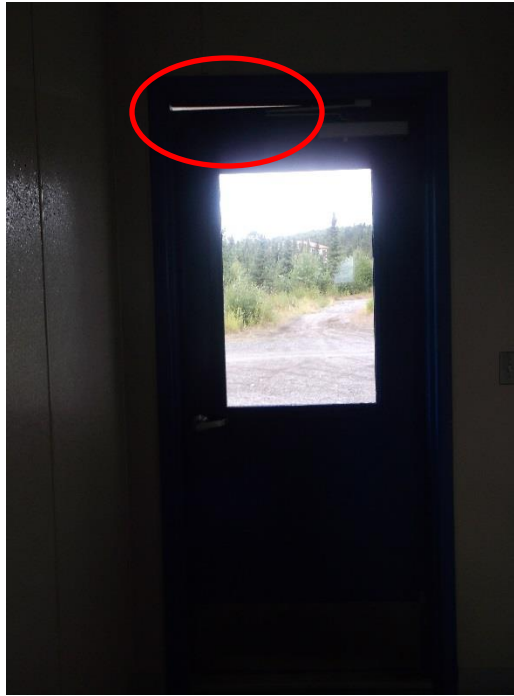
There are 4 exterior doors in the Lime Village Washeteria, one in the arctic entry, two in the water treatment room, and one giving access to the watering point. All four doors are metal with an EPS core and an area of around 21 square feet. The arctic entry and watering point doors are half-lite while the water treatment room doors contain no glass. The arctic entry and water treatment plant doors are not closing properly due to the foundation settling.

Figure 1: Door in Artic Entry, needs to be weatherized

Rank	Location	Existing Air Leakage Level (cfm@50/75 Pa)	Recommended Air Leakage Reduction (cfm@50/75 Pa)		
9		Air Tightness estimated as: 2500 cfm at 50 Pascals	Add weatherization around exterior doors.		
Installation Cost	\$500	Estimated Life of Measure (yrs)	10	Energy Savings (/yr)	\$205
Breakeven Cost	\$1,871	Savings-to-Investment Ratio	3.7	Simple Payback yrs	2
Auditors Notes: The building foundation has settled and as such the door frames have been warped out of shape. As a result the exterior doors do not fit properly into the door frames and large cracks are around the frames. Add weather stripping and insulation to prevent air leakage into the building.

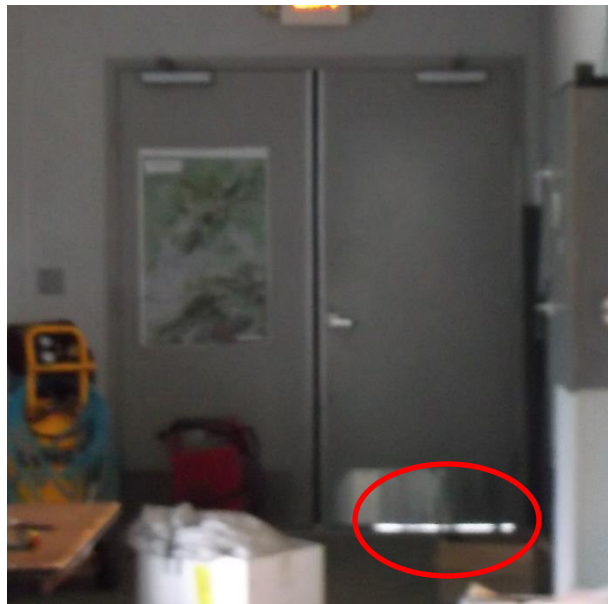
Figure 2: Door in Water Treatment Plant, needs to be weatherized

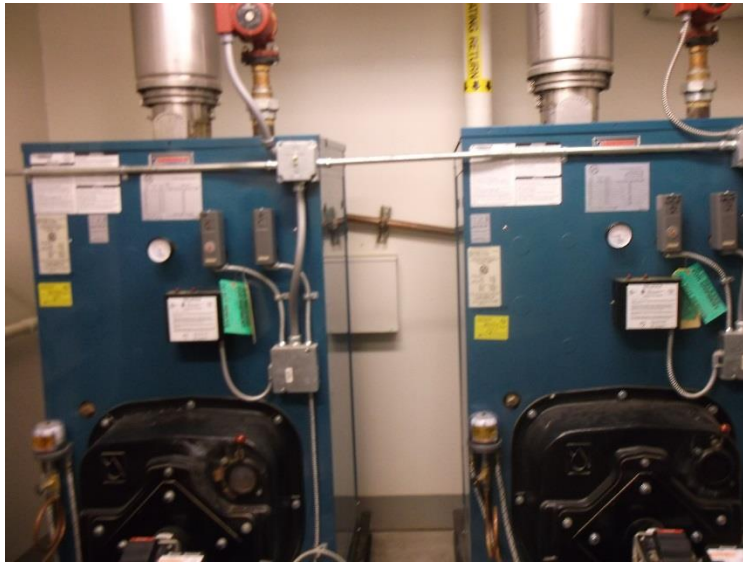
Fuel Type: #1 Oil  
Input Rating: 420,000 BTU/hr  
Steady State Efficiency: 75 %  
Idle Loss: 0 %  
Heat Distribution Type: Glycol  
Boiler Operation: Oct - Apr

Figure 3: Boilers used in the Lime Village Washeteria

The existing Tekmar boiler controller does not sequence the boiler operation properly. This unit was installed after a previous unit burned out and there was no corresponding replacement of the same model. The Tekmar is improperly programmed and is not wired correctly for effective boiler operation. This unit needs to be rewired and reprogrammed for a primary – secondary boiler operation system.

The boiler heat is not being effectively distributed to the main glycol circulation loop. The boiler temperature set points are at 185 ° F but the main glycol loop temperatures were between 105-115 ° F. Discussions after the site visit with an operations engineer revealed that the highest temperature that the loop will reach is around 140-145 ° F. The heat is not being distributed properly and likely causes include faulty boiler circulation pumps, broken check valves, or congestion within the pipe. Repairs to this will allow the boiler to operate much more efficiently and reduce boiler run time in the winter.

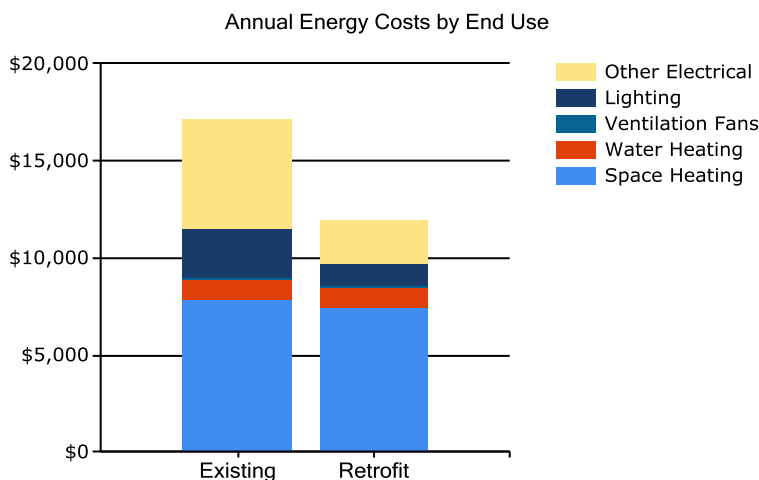
Figure 4 below reflects the estimated distribution of costs across the primary end uses of energy based on the AkWarm© computer simulation. Comparing the “Retrofit” bar in the

figure to the “Existing” bar shows the potential savings from implementing all of the energy efficiency measures shown in this report.

**Figure 4: Annual Energy Costs by End Use**

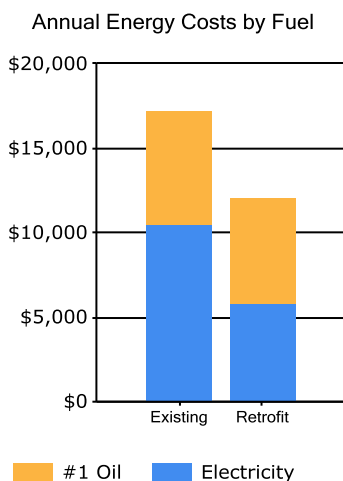
Figure 5 below shows how the annual energy cost of the building splits between the different fuels used by the building. The “Existing” bar shows the breakdown for the building as it is now; the “Retrofit” bar shows the predicted costs if all of the energy efficiency measures in this report are implemented.

**Figure 5: Annual Energy Costs by Fuel Type**

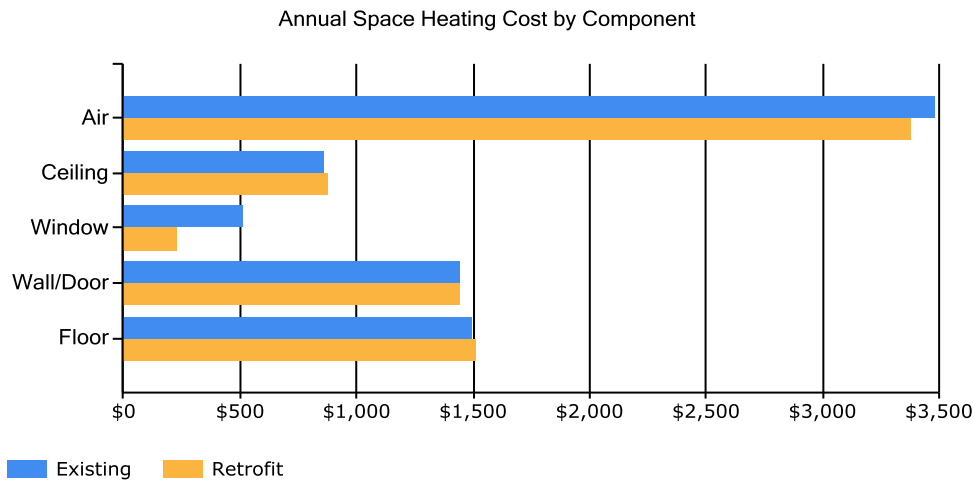
Figure 6 below addresses only Space Heating costs. The figure shows how each heat loss component contributes to those costs; for example, the figure shows how much annual space heating cost is caused by the heat loss through the Walls/Doors. For each component, the space heating cost for the Existing building is shown (blue bar) and the space heating cost assuming all retrofits are implemented (yellow bar) are shown.

**Figure 6: Annual Space Heating Cost by Component**

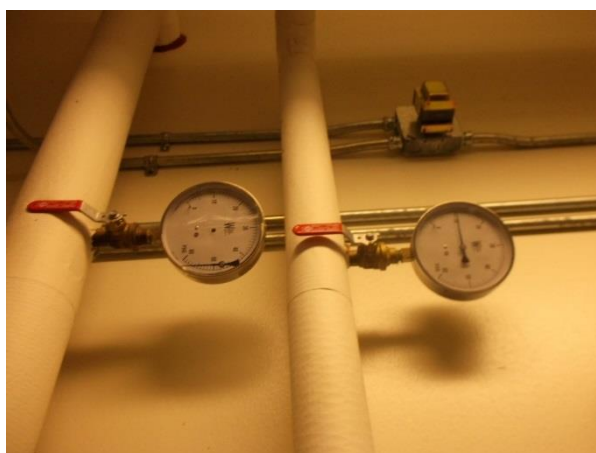
The temperature and pressure gauges in the mechanical room were all damaged with the needles either bent or detached from the base pins. This was the result of a single incident where violent pressure spikes caused the heating system to give a loud pounding and banging sound. Replacing these gauges will allow for more secure operation of the facility.

**Figure 7: Broken Gauges within the Mechanical Room**

Repair Faulty Gauges: \$390

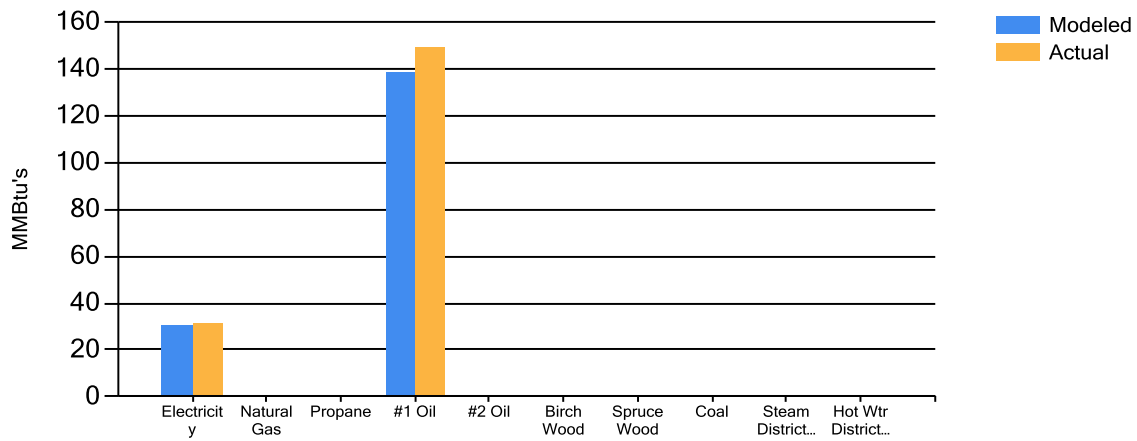
The orange bars show actual fuel use, and the blue bars are AkWarm’s prediction of fuel use.

Figure 8: Annual Fuel Use

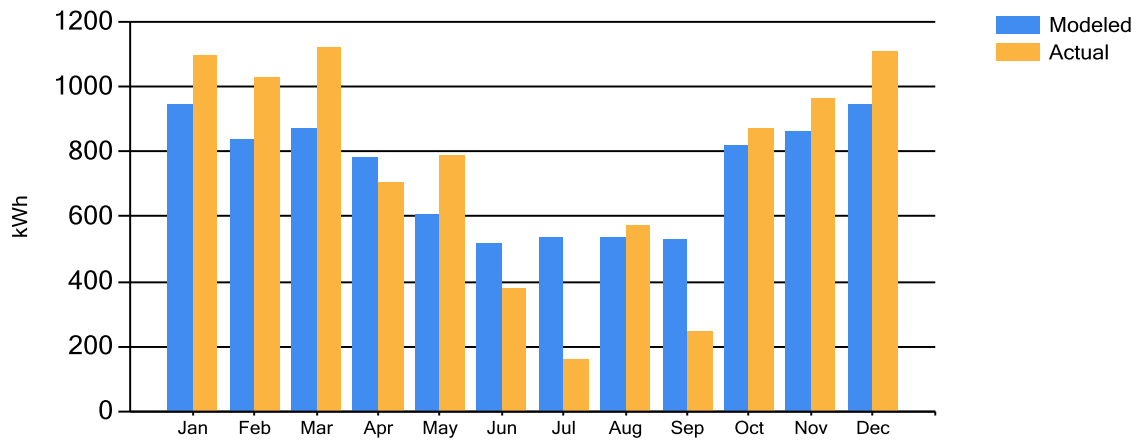
Figure 9: Electricity Fuel Use

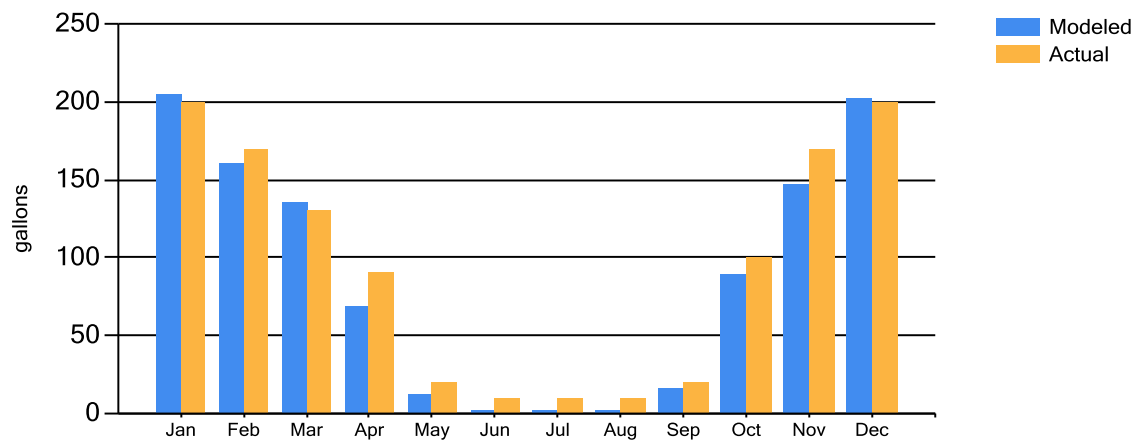
Figure 10: #1 Fuel Oil Fuel Use
