# Comprehensive Energy Audit For Chistochina Community Hall

Prepared For  
**Cheesh'Na Tribe**

**March 25, 2019**

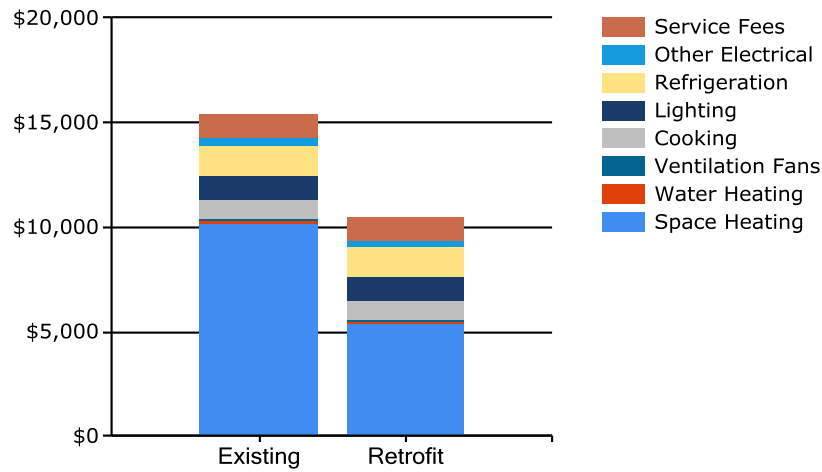
**Figure 1.1: Annual energy costs by use before and after EEMs.**

Figure 1.1 below reflects the estimated distribution of costs across the primary end uses of energy based on the AkWarm© computer simulation. Comparing the “Retrofit” bar in the figure to the “Existing” bar shows the potential savings from implementing all of the EEMs shown in this report. Figure 1.2 shows the change in fuel usage after the recommended EEMs are installed.

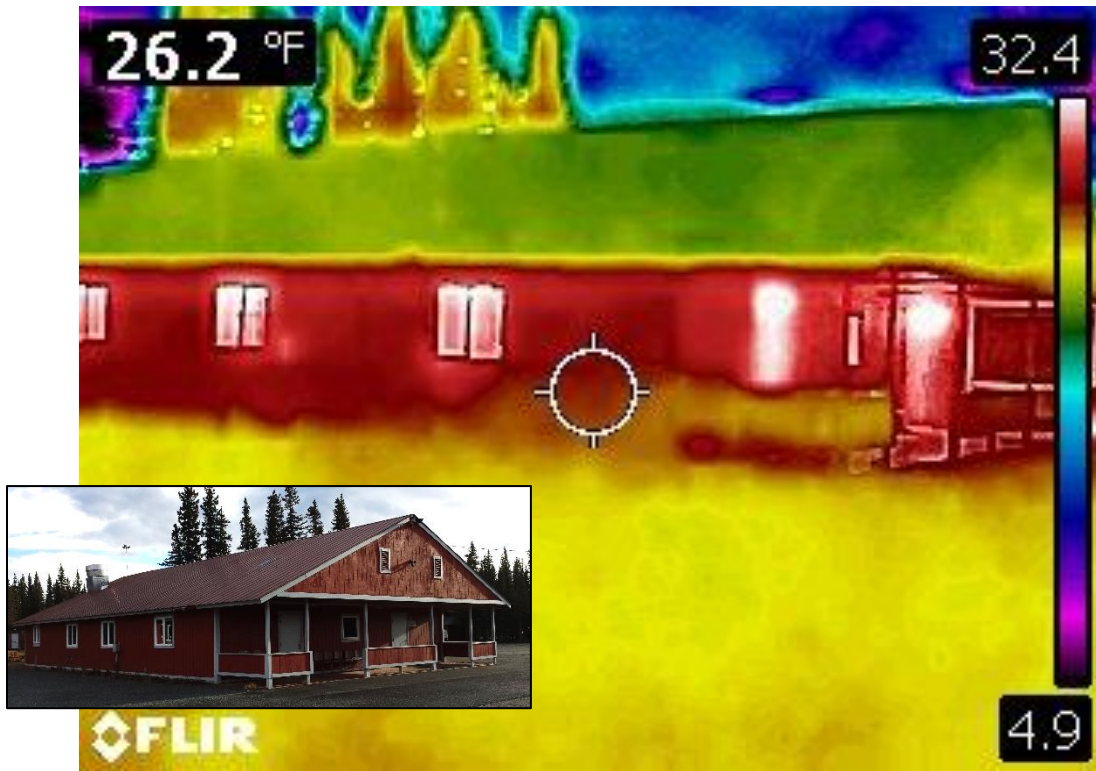
**Figure B1. Thermal imaging of the Chistochina Community Hall (inset photo actual building). The color gradient on the right corresponds to degrees Fahrenheit, ranging from white (32.4°F) to black (4.9°F). The areas of white demonstrate a large amount of heat loss through the Community Hall windows and doors. The walls, shown in red, are the second largest source of heat loss.**

The interior and exterior of the building are in good condition, but the wall insulation likely needs to be replaced for two reasons. First, loose fill and fiberglass batting falls over time simply due to gravity. This can be problematic below windows if the batting or loose fill was not packed properly. Second, the building was constructed using inexperienced carpenters, so the insulation may not have been installed correctly in the first place. The two backdoors to the kitchen and janitor/storage spaces have visible gaps around them. Replacing the weather stripping and door sweeps around all of the doors is recommended.

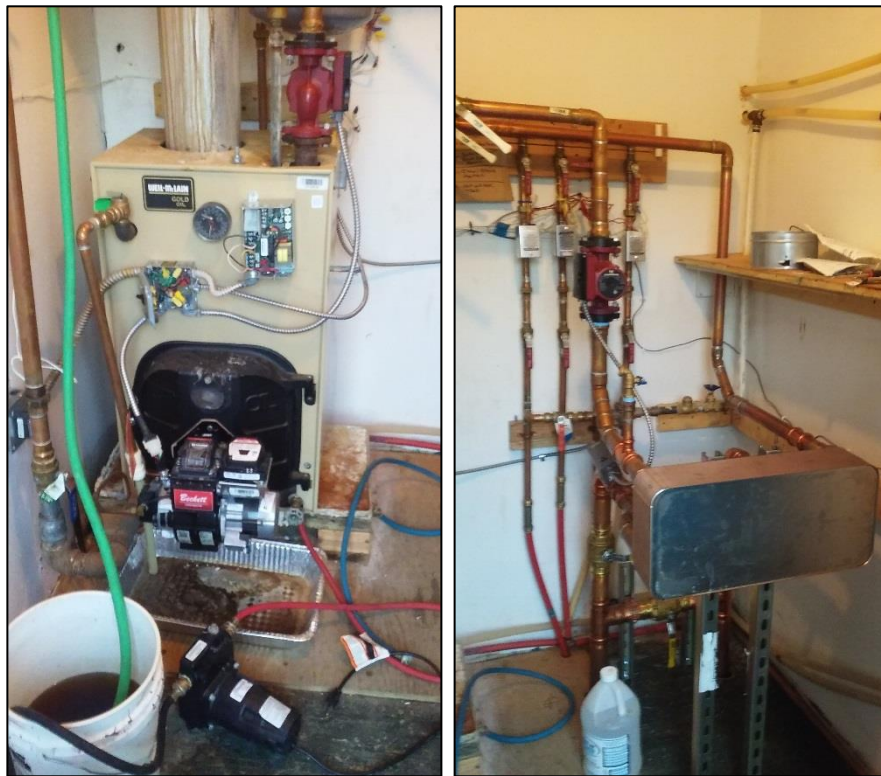
The Chistochina Community Hall is heated year-round by an oil-fired boiler. It also heats a 41-gallon indirect hot water generator located in the hall's boiler room. The oil-fired boiler does not have a fuel filter or an oil de-aerator, and likely has not been serviced in some time. Unfortunately, the glycol piping, flue pipe, and boiler controls configuration would make brushing out the boiler cast iron sectionals difficult.

From November to about June of each year, the boiler return glycol supply is preheated by a pellet-fired district heating boiler. Heated glycol is circulated through approximately 90 feet of buried transmission line to a 210,000 BTU per hour brazed plate heat exchanger located in the Community Hall's boiler room. The transmission line is insulated (R-4.75 closed cell foam insulation); however, snowmelt is evident where the lines are buried.

Figure B2. Community Hall boiler (left) and district heating heat exchanger (right).

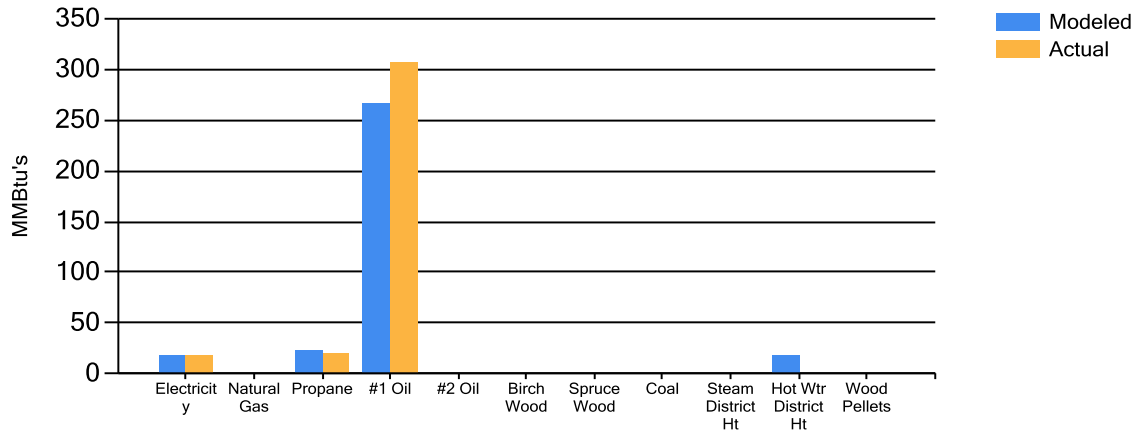
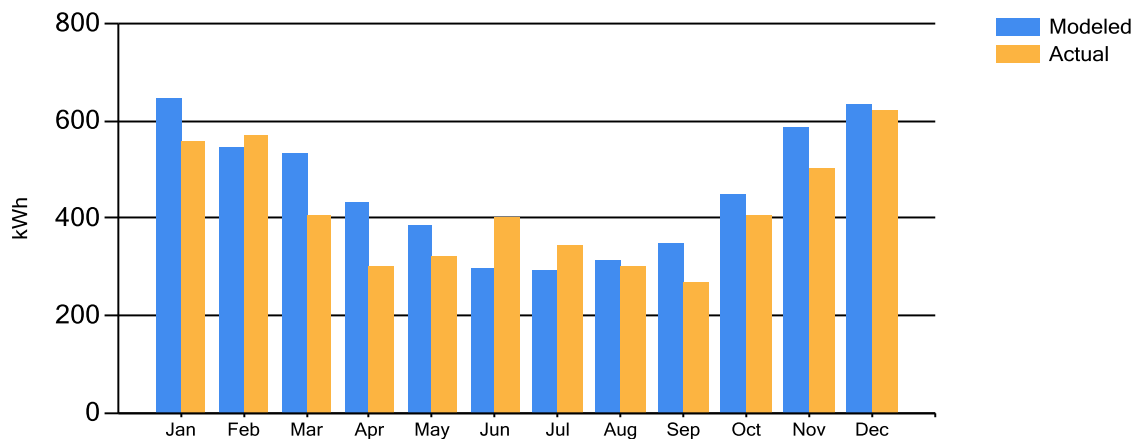
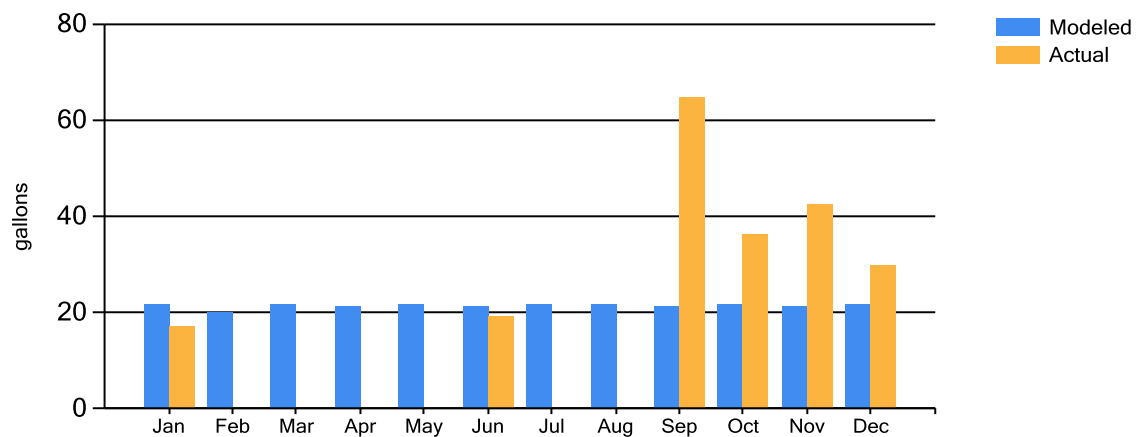
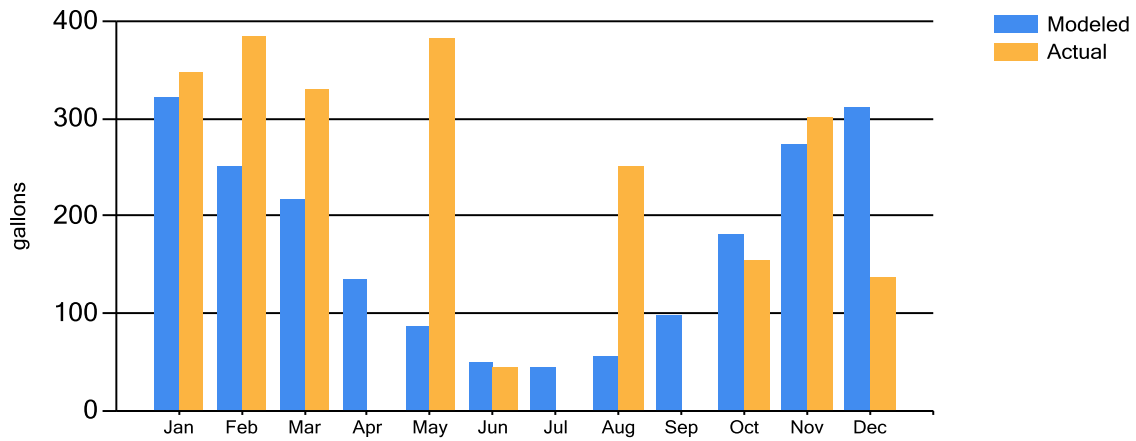
The graphs below show the modeled energy usage results of the energy audit process compared to the actual energy usage report data. The model was completed using AkWarm© modeling software. The orange bars show actual fuel use, and the blue bars are AkWarm©'s prediction of fuel use.

*Note: The "actual" fuel usage above is by delivery, not the amount used during the month.*

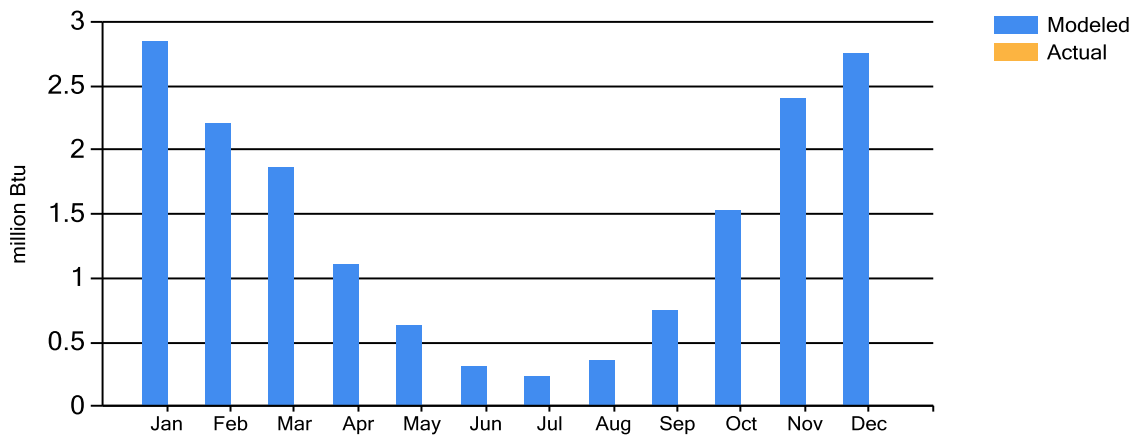
### Pellet-Fired District Heating System

*Note: The pellet-fired boiler is only used from November through June. Any heating requirements in the chart above would be supplied by the Weil-McLain boiler.*
