# Comprehensive Energy Audit For

# Solomon Bed and Breakfast

Prepared For Village of Solomon

August 20, 2018

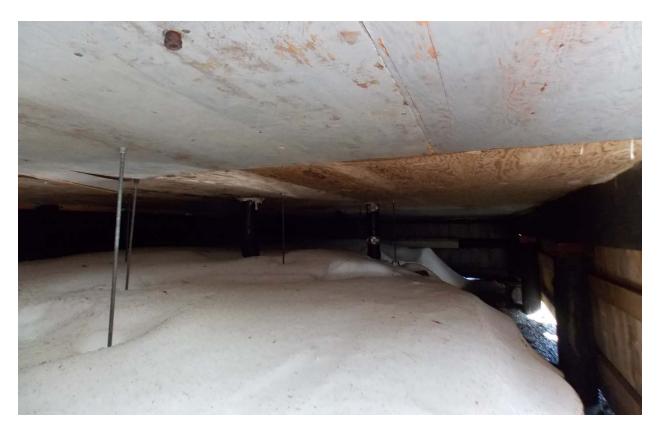
Inside the crawlspace under the building floor. Snow builds up under the building over the course of the winter, creating potential freeze problems for any exposed, uninsulated plumbing once the building is reopened in the summer. The gaps between the ground and the crawlspace walls should be sealed to prevent snow intrusion. The Solomon Bed and Breakfast may consider insulating all exterior plumbing for another layer of protection

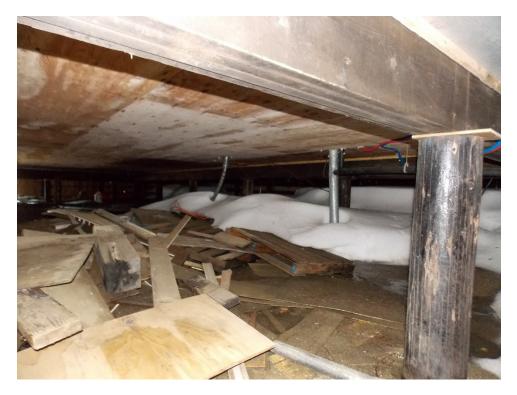
The subfloor appeared to be well sealed and in good condition at the time of the site visit. All plumbing penetrations could use additional spray foam insulation on both the exterior and interior of the building.

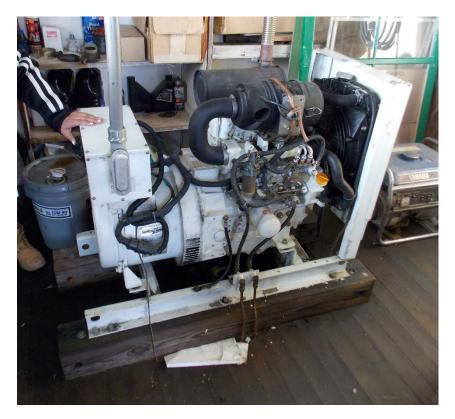
Northern Lights 10 kW diesel generator. All of the electricity consumed by the Solomon Bed and Breakfast is generated on site.

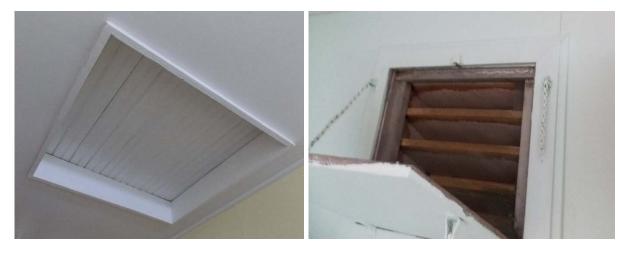
Wall and ceiling penetrations, such as attic hatches and two baffled vents in the kitchen, are not well insulated. Adding rigid foam insulation would help prevent heat loss at these points.

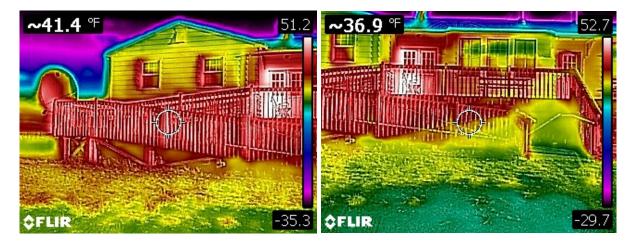
FLIR thermal imaging of the building front. The color gradient on the right in each image depicts the temperature range of the photo (in degrees Fahrenheit). Colors in the higher end of the gradient indicate where heat is being lost. Note the white area at the double door off of the Classroom. There was a gap between the door and doorframes at that location. Installing weather-stripping, new door sweeps, and insulated storm doors will reduce heat loss at this area.

The two windows in the image on the left are double paned, but do not have a storm window. The three windows in the image on the right are double paned and have single pane storm windows installed on the exterior. There is visibly less heat loss through the windows in the right-side image.

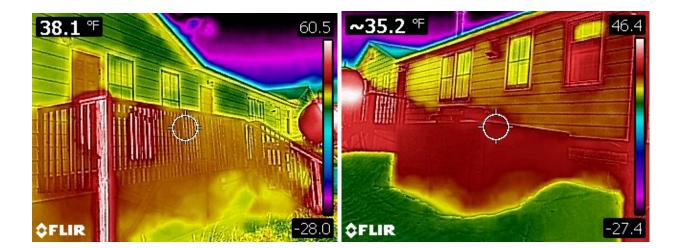
FLIR thermal imaging of the building rear. The color gradient on the right in each image depicts the temperature range of the photo (in degrees Fahrenheit). Colors in the higher end of the gradient indicate where heat is being lost. Note: sunlight was heating the porch post in the left-hand image. There is no heat loss through that point.
