# Comprehensive Energy Audit For

# Hughes Water Treatment Plant & Washeteria

Prepared For City of Hughes

November 11, 2016

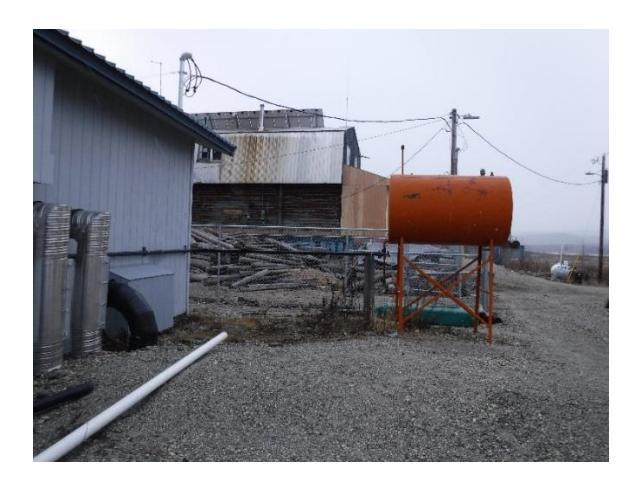
There are two major operational hazards within the water treatment plant that need to be addressed outside of energy efficiency efforts. The existing fuel tank is a single-walled 500 gallon tank that is original to the construction of the building. The tank is located approximately 30 ft. from the site of the water intake well and there is no catchment or containment system for the fuel tank should a spill occur. This must be addressed with the installation of a double-walled tank with a catchment system and by relocating the tank further away from the well site. Additionally, the backup generator is currently located in the process room next to the water circulation loops and has no provisions for make-up air required for generator operation. The generator must be given make-up air in order to correct code violations and insure the safety of building occupants. Our recommendation is to build a separate small building container for the backup generator and install the unit outside of the building.

Figure 1: The existing fuel tank can be seen with no catchment system for any leaking fuel.

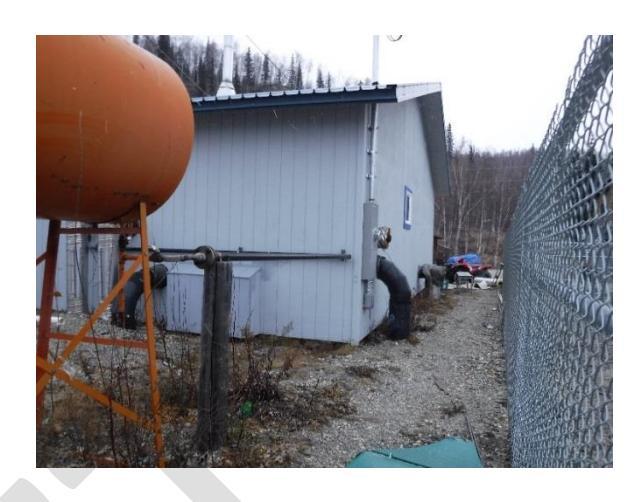
Figure 2: The proximity of the fuel tank to the groundwater well for the community.

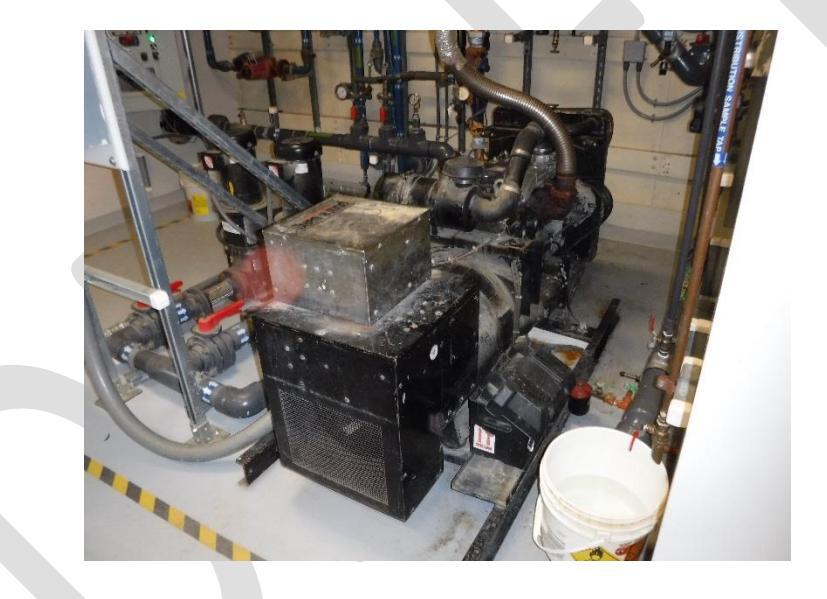
Figure 3: The backup generator can be seen with no source of makeup air for its operation.

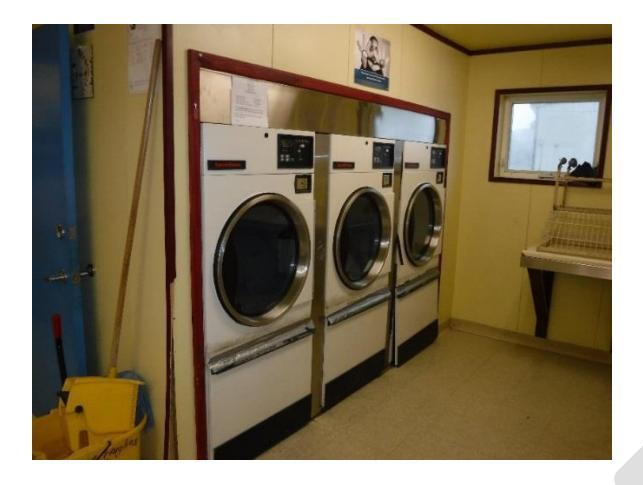
gallon capacity. One of the 18-gallon washer units was not functional at the time of the site visit. The three dryers were all functioning with proper heating temperatures observed. The dryers are supplied with heat from a dedicated boiler that operates on demand. The boiler also supplies heat for the air handling unit in the loft that serves the washeteria space.

Figure 4: Hydronic Dryers in the Hughes Washeteria

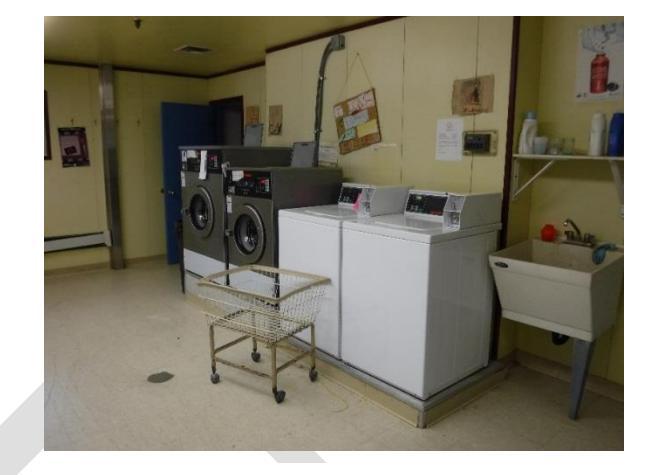
The washeteria has four clothes washers and three hydronic clothes dryers for use by the community. Three of the washers have an 18-gallon capacity while the fourth washer has a 30-

Figure 5: Clothes Washers in the Hughes Washeteria

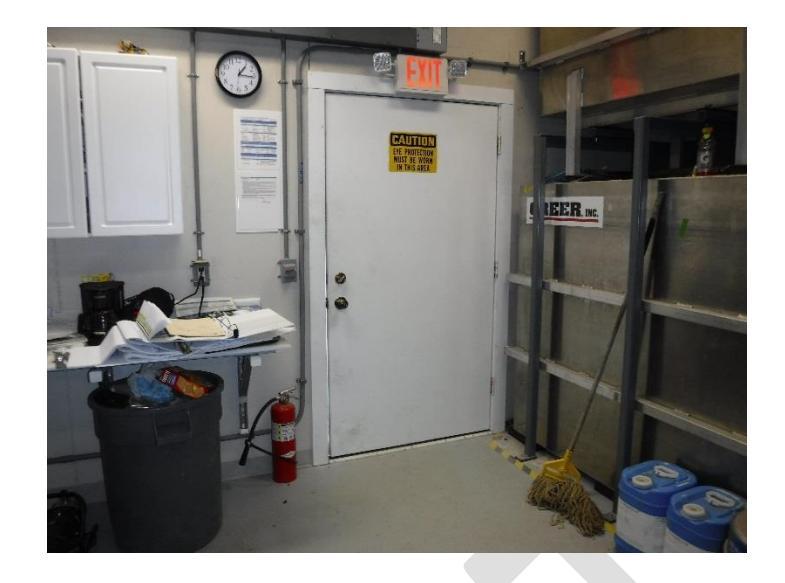
There are two entrances into the building. The washeteria entrance has an arctic entry with poorly insulated doors. The door to the washeteria is a solid wood door with a metal skin. The water treatment plant entrance has a wood door with metal skin that is slightly larger than a standard door with dimensions of 42" x 80". The door is not set in the hinges properly and air leakage is very high as a result.

Figure 6: The washeteria entrance door can be seen with visible gaps around the edge where air leakage occurs.

Rank	Location	:	Size/Type, Condition		Recommendation				
18	Exterior Doc	or:	Door Type: Entrance, Wood, solid co	re flush, 1-3/4"	Remove existing door and install standard insulated				
	Washeteria	Door	Modeled R-Value: 2.6		metal door.				
Installation Cost \$2		\$2,01	27 Estimated Life of Measure (yrs)	30	Energy Savings (\$/yr)	\$34			
Breakev	ven Cost	\$70	00 Simple Payback (yrs)	60	Energy Savings (MMBTU/yr)	1.2 MMBTU			
	Savings-to-Investment Ratio 0.3								
Auditors x 70".	Auditors Notes: Replacing the door will improve the overall insulation qualities and reduce air leakage through the door cracks. This door is 36" x 70".

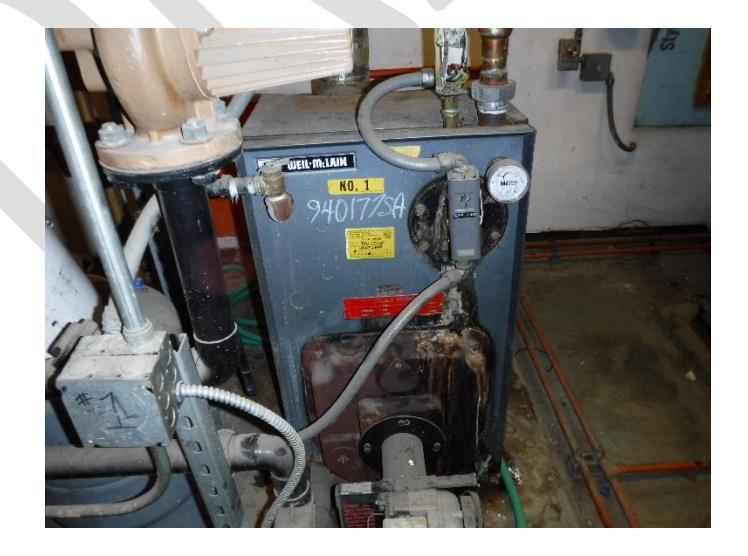
Figure 7: Boiler 1

Nameplate Information:

Weil McLain CP 1405962

Fuel Type:	#1 Oil
Input Rating:	125,200 BTU/hr
Steady State Efficiency:	78 %
Idle Loss:	1.5 %
Heat Distribution Type:	Glycol
Boiler Operation:	All Year

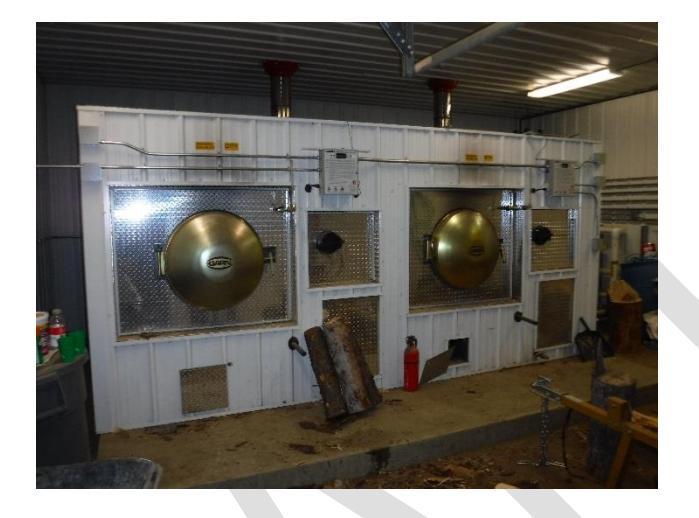
Nameplate Information: Fuel Type: Input Rating: Steady State Efficiency: Idle Loss: Heat Distribution Type: Boiler Operation: Garn 1000 Spruce Wood 180,000 BTU/hr 80 % 2 % Water Sep – May

#### Figure 10: Garn 1000 Biomass Boilers

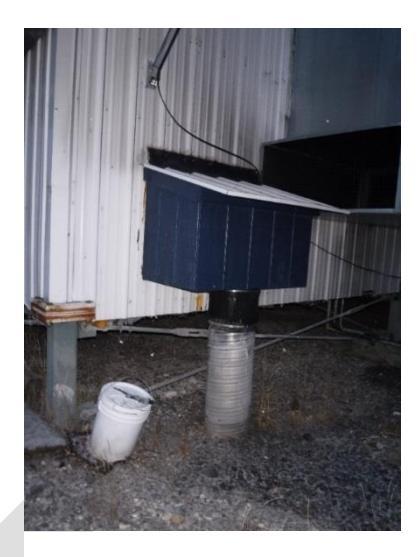
Figure 12: The water main penetrates the power plant wall to get reheated by the heat recovery system.

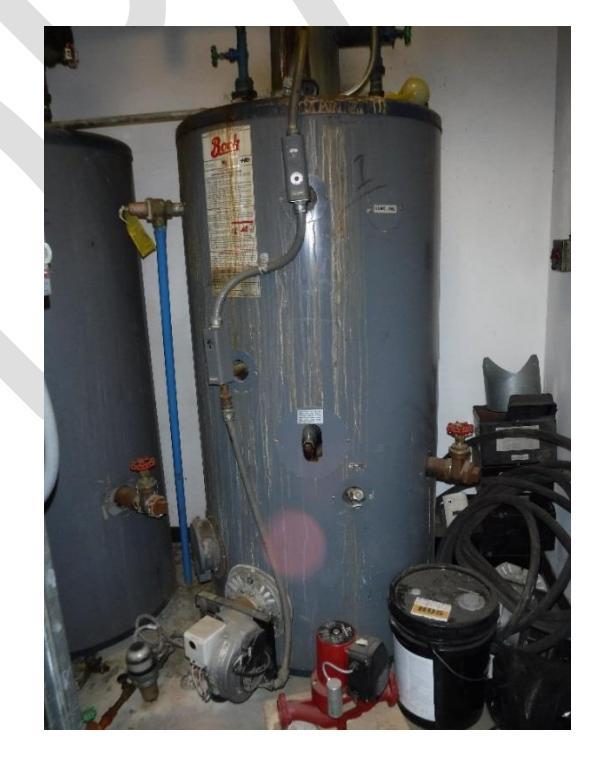
Fuel Type: Input Rating: Steady State Efficiency: Idle Loss: Heat Distribution Type: Boiler Operation: #1 Oil 277,000 BTU/hr 78 % 0 % Water All Year

Figure 13: Independent Direct-Fired Hot Water Heater

The building has two independent hot water heaters present that provide heated water to the restrooms, showers, sinks, and washers in the building. One of the heaters has been taken offline and the parts used to repair the other heater, leaving only one in operation. Both heaters are Bock units with 100 gallons of storage. It is estimated that the facility uses approximately 23 gallons of hot water per day.

There a been sa gallon, : hot wat	re two Bock 10 Ivaged for the 100 MBH indir er heater into	00 gallon indepen burner. The othe ect water heater. the expanded hea	dent hot water heaters that are us er heater is rated for 277 MBH. Der With the installation of a new boil ating loop will allow the biomass b	ed for domestic l nolish both exist er and a new prin piler to cover the	hot water purpose ing fuel fired hot v mary-secondary sy e domestic hot wa	es. One of them water heaters ar ystem, the insta ter loads as avai	is inoperable and has nd install a new 125 lation of an indirect- lable.		
With the expande	e implementat ed heating loo	tion of a primary- p. Install new Ma	secondary system, the existing buil gna3 VFD pumps to accommodate	ding primary hea the mechanical	at circulation pum room renovations	ps will be inade 5.	quately sized for the		
All of th marsha higher,	e boiler replac . This has bee the mechanica	cement and heatir en budgeted into t al room will have t	ng loop renovation work will requir the cost estimate. Also, if the boile to be inspected to determine if the	e a stamped dra r replacement in walls are approv	wing from an engi Icludes any boiler Ved for a 1-hour fi	ineer and a perr that is rated for re rating.	nit from a fire 600,000 BTUh or

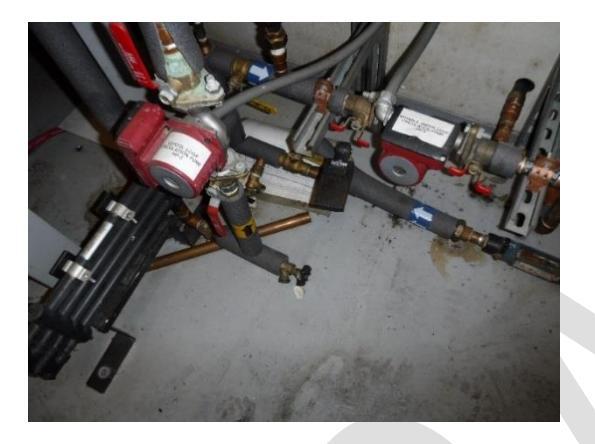
There is a heat recovery system that provides heat from the cooling loops of the power plant generators to the south loop. The system ties in directly to the water main and provides a second heating source along the loop to prevent freezing on the far end of the circulation loop. In the winter of 2015, the water line for the heat recovery froze and a sight glass ruptured, causing the room to flood. Since that rupture, the pipe has not been insulated and the sight glass is still broken. As a result, the heat recovery system currently provides space heat for the power plant building but is not assisting with the water circulation loop.

Figure 18: Heat Recovery System heat exchanger for the water main

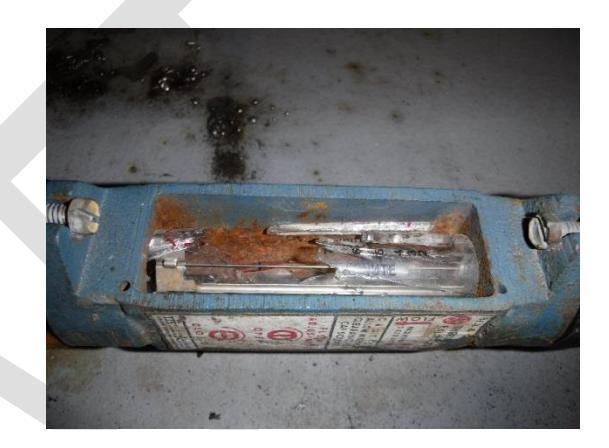
Figure 19: Broken Sight Glass where water flooded the power plant.

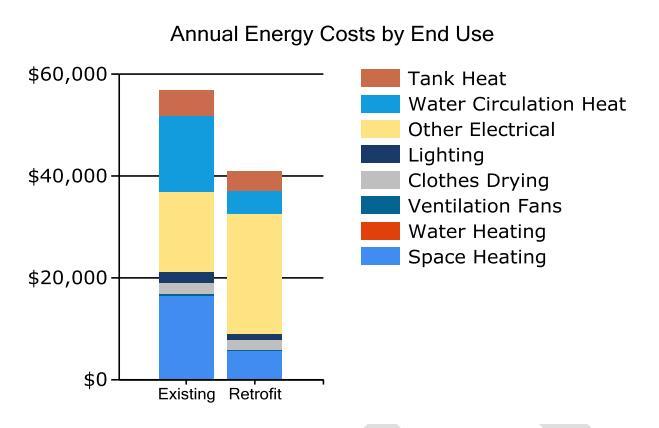
Figure 20 below reflects the estimated distribution of costs across the primary end uses of energy based on the AkWarm<sup>©</sup> computer simulation. Comparing the "Retrofit" bar in the

figure to the "Existing" bar shows the potential savings from implementing all of the energy efficiency measures shown in this report.

Figure 20: Annual Energy Costs by End Use

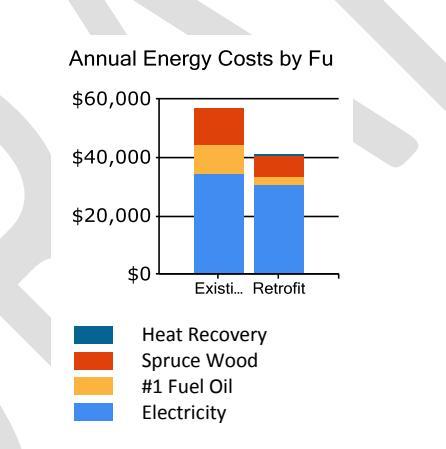
Figure 21 below shows how the annual energy cost of the building splits between the different fuels used by the building. The "Existing" bar shows the breakdown for the building as it is now; the "Retrofit" bar shows the predicted costs if all of the energy efficiency measures in this report are implemented.

Figure 21: Annual Energy Costs by Fuel Type

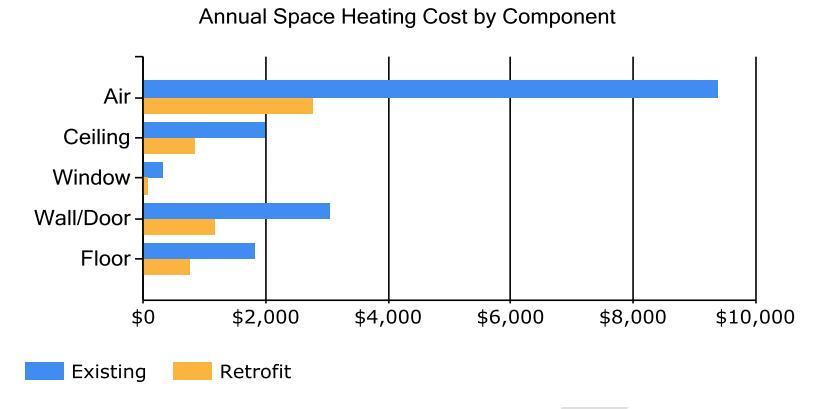
Figure 22 below addresses only Space Heating costs. The figure shows how each heat loss component contributes to those costs; for example, the figure shows how much annual space heating cost is caused by the heat loss through the Walls/Doors. For each component, the space heating cost for the Existing building is shown (blue bar) and the space heating cost assuming all retrofits are implemented (yellow bar) are shown.

Figure 22: Annual Space Heating Costs

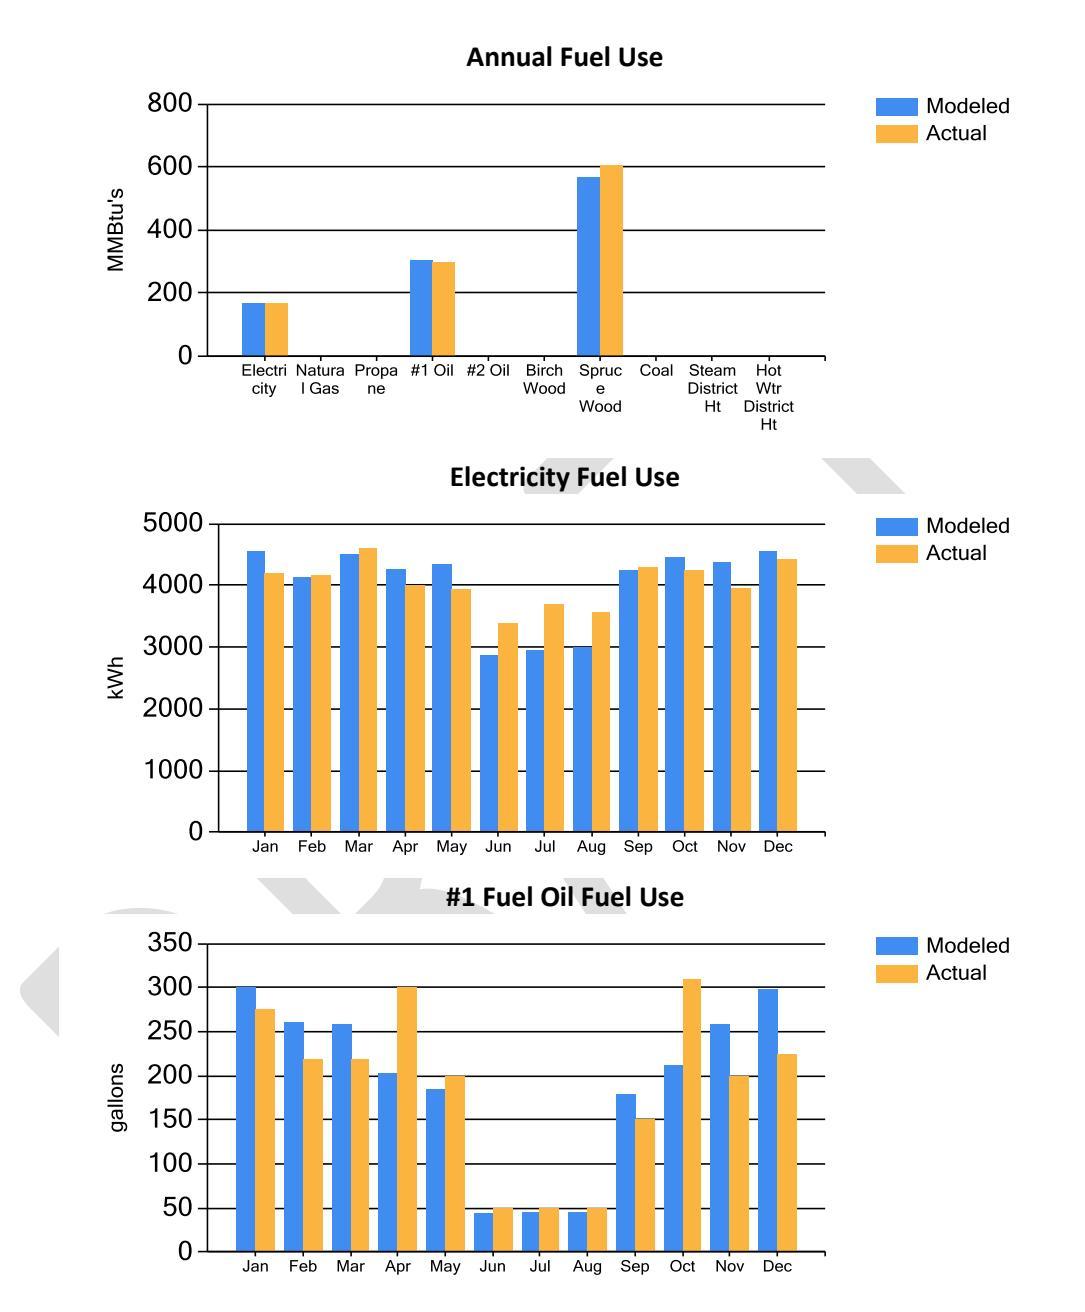
The graphs below show the modeled energy usage results of the energy audit process compared to the actual energy usage report data. The model was completed using AkWarm modeling software. The orange bars show actual fuel use, and the blue bars are AkWarm's prediction of fuel use.
