## Comprehensive Energy Audit For Mountain Village Middle Pump House, Cannery Well House and Lift Stations

Prepared For City of Mountain Village

May 18, 2017

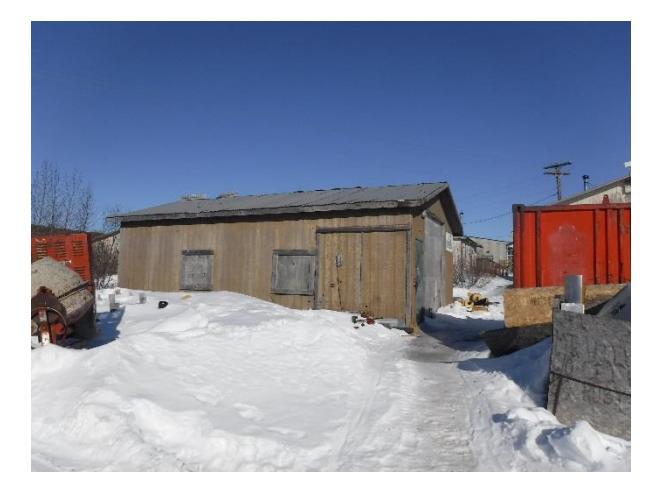
Figure 2: Middle Pump House Garage

There is a garage next to the Middle Pump House that houses maintenance equipment for the water system and for the city. Occupancy of the garage is infrequent and the only energy use comes from incandescent lights in the building.

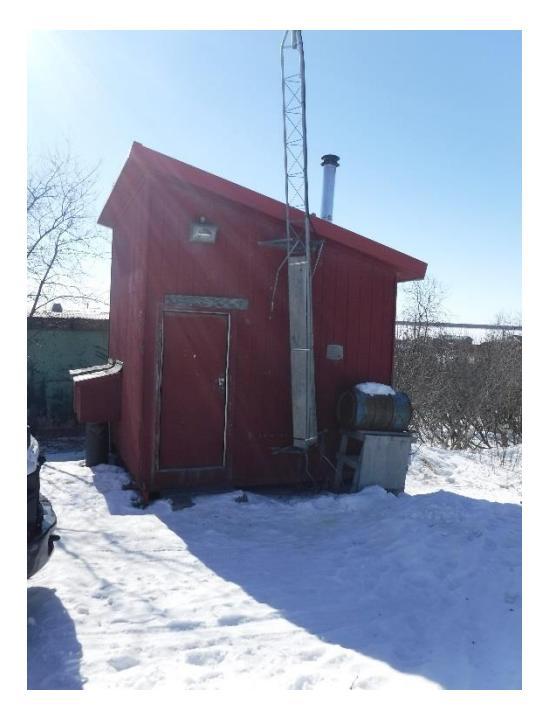
Figure 3: Cannery Well house

The Cannery Well house is the location of the Cannery Well and #6 Well, which supply the lower portion of the community with water. The building holds the chlorine treatment system as well.

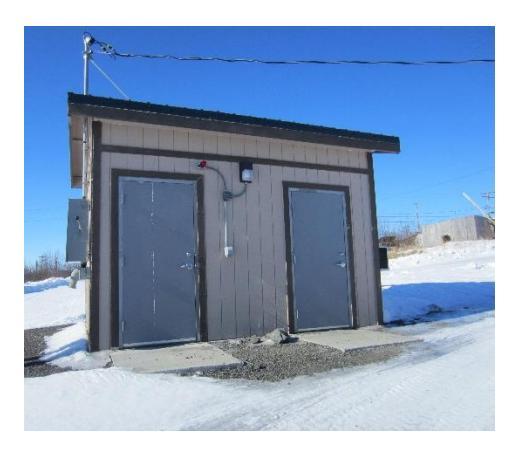
Figure 4: Lift Station 1

There are three lift stations in the lower part of the community that collect sewage from the facilities in the town and transport it to the sewage lagoon outside of town. One of the lift stations has been disconnected from the electric utility and was not included in this audit report. The other two are referred to as Lift Stations 1 and 2 by the community and are located in the southeast and southcentral regions of the community, respectively.

Rank	Location	D	Description of Existing Eff			Efficiency Recommendation				
1		Li	Lift Station 1 Electric Heat			Lower thermostat to 40 °F				
Installation Cost		\$500	Estimated Life of Measure (yrs)	1	15	Energy Savings (\$/yr)	\$1,573			
Breakev	en Cost	\$18,483	Simple Payback (yrs)		0	Energy Savings (MMBTU/yr)	13.8 MMBTU			
			Savings-to-Investment Ratio	37.	.0					
Auditors	Auditors Notes: Lower the thermostat to 40 °F so that the lift station has freeze protection without using excess heating.

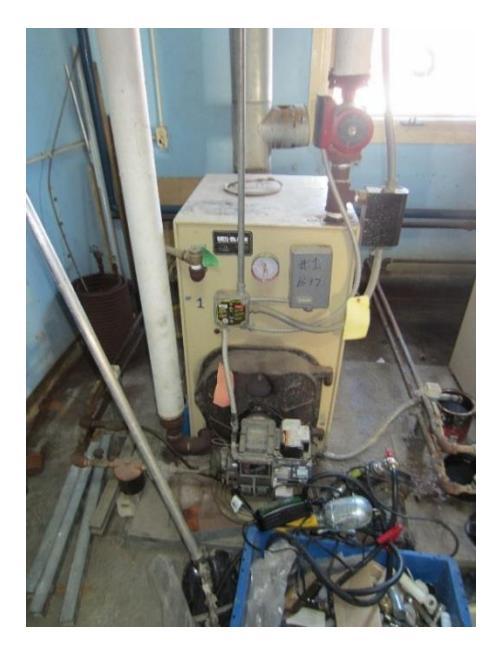
Figure 6: Middle Pump House Boiler 1

Weil McLain Model P-WGO-6
Pump = Grundfos UP 26-64F
#1 Oil
184,000 BTU/hr
73 %
1.5 %
Glycol
Oct – May

Fire Rate: Notes: 1.75 GPH Data logger showed this running 10% of the time

Rank	Recommend	dation								
12	Replace gun	s, tune and clean	boilers, get boiler 2 operational, a	dd controls, repla	ace thermostats in the building.					
Installa	Installation Cost \$6,00		Estimated Life of Measure (yrs)	20	Energy Savings (\$/yr)	\$331				
Breakeven Cost		\$6,016	Simple Payback (yrs)	18	Energy Savings (MMBTU/yr)	9.0 MMBTU				
			Savings-to-Investment Ratio	1.0						
Auditor	Auditors Notes: The addition of new guns will improve the fuel-firing rate and allow for a more efficient burn in the boiler.									
Tuning Boiler 2 system	Tuning and cleaning the boilers will improve the combustion efficiency and improve the burn of the fuel in the boiler. Boiler 2 was not in operation during the site visit. Adding this to the building operations will allow the building to use a lead-lag boiler control system and improve the overall operations of the facility.									
Replace	e Guns	\$1500

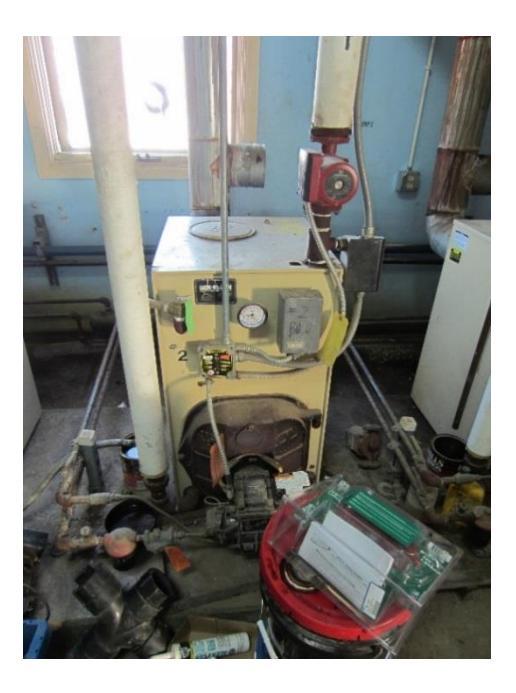
Figure 7: Middle Pump House Boiler 2

Fuel Type: Input Rating: Steady State Efficiency: Idle Loss: Heat Distribution Type: Boiler Operation: Fire Rate: Notes: Weil McLain Model P-WGO-6 Pump = Grundfos UP 26-64F #1 Oil 184,000 BTU/hr 75 % 0 % Glycol Oct – May 1.75 GPH This is not in operation. Data logger showed this running 0% of the time.

Tune ar	nd Clean Boiler	s \$1500								
Repair	Boiler 2	\$1000								
Add Bo	Add Boiler Controls \$2000									
Total		\$6000

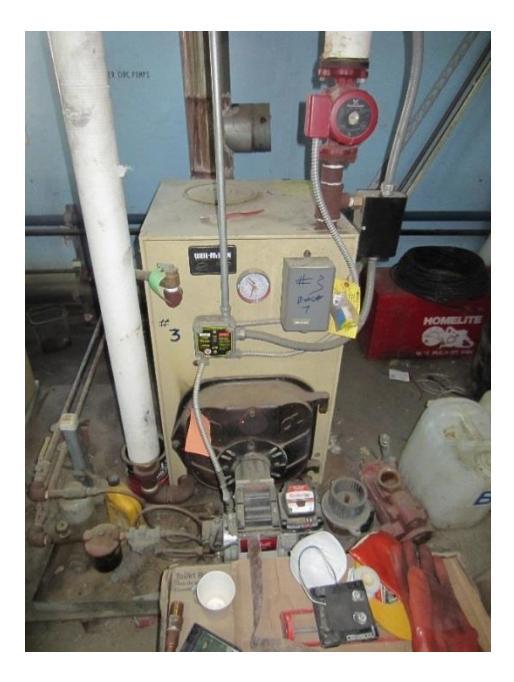
Figure 8: Middle Pump House Boiler 3

Fuel Type: Input Rating: Steady State Efficiency: Idle Loss: Heat Distribution Type: Boiler Operation: Fire Rate: Notes: Weil McLain Model P-WGO-6 Pump = Grundfos UP 26-64F #1 Oil 184,000 BTU/hr 82 % 1.5 % Glycol Oct – May 1.75 GPH Data logger showed this running 51% of the time

The demand for heat in the middle pump house is seasonal and includes space heating and a heat add system that serves the upper distribution loop and water storage tank. Thermostats in the building appeared to not be functional, but temperature measurements indicated an air temperature of approximately 65 °F.

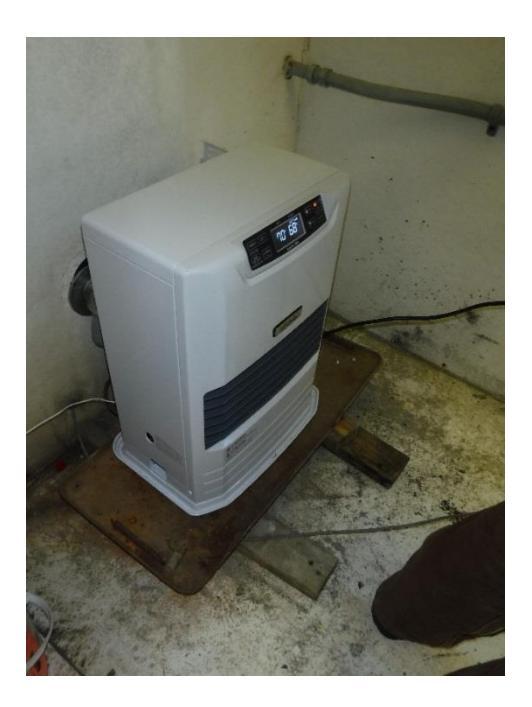
Figure 9: Cannery Well house Toyo 300 Stove

#### Toyo Laser 300 – Well House

Nameplate Information:	Toyotomi Laser 300, set to 70 deg F
Fuel Type:	#1 Oil
Input Rating:	14,400 BTU/hr
Steady State Efficiency:	87 %
Idle Loss:	0 %

Rank	Location	De	escription of Existing	l	Efficiency Recommendation					
2		Cannery Well Space Heat				Reprogram Toyo Laser 300 to heat up to 40 °F.				
Installation Cost \$		\$500	Estimated Life of Measure (yrs)		15	Energy Savings (\$/yr)	\$519			
Breakeven Cost		\$7,030	\$7,030 Simple Payback (yrs)		1	Energy Savings (MMBTU/yr)	11.9 MMBTU			
			Savings-to-Investment Ratio	14	1.1					
Auditors	Auditors Notes: Lower the Toyo stove to 40 °F so that the well house has freeze protection without using excess heating.

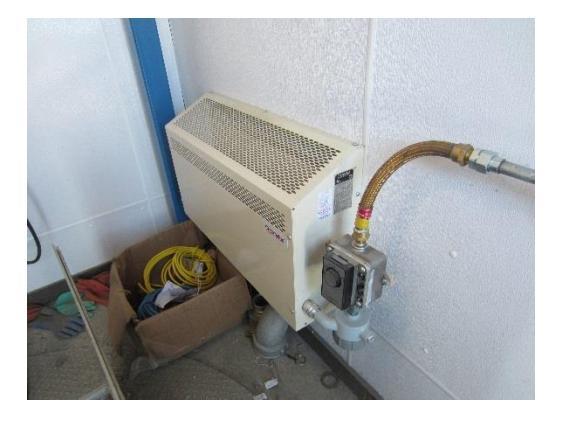
Figure 10: Lift Station 1 Electric Heater

#### Lift Station 1 Electric Heater

Fuel Type:	Electricity
Input Rating:	0 BTU/hr
Steady State Efficiency:	100 %
Idle Loss:	0 %
Heat Distribution Type:	Air

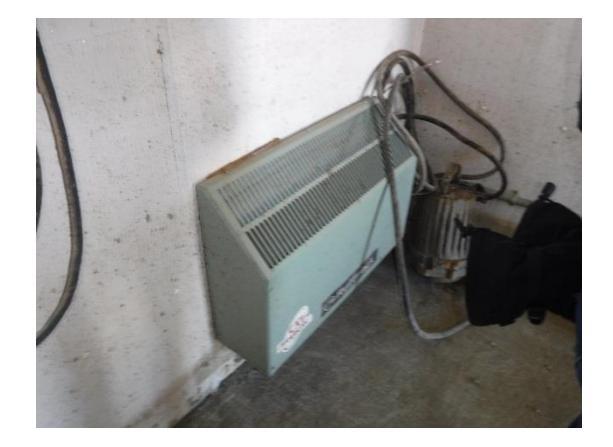
Figure 11: Lift Station 2 Electric Heater

#### Lift Station 2 Electric Heater

Fuel Type:	Electricity
Input Rating:	0 BTU/hr
Steady State Efficiency:	100 %

Rank	Location	Description of Existing				Efficiency Recommendation				
8		Lift Station 2 Electric Heat				Lower thermostat set point to 40 °F				
Installation Cost \$50			Estimated Life of Measure (yrs)	1	15	Energy Savings (\$/yr)	\$157			
Breakeven Cost		\$1,848 Simple Payback (yrs)			3	Energy Savings (MMBTU/yr)	1.4 MMBTU			
			Savings-to-Investment Ratio	3.	.7					
Auditors	Auditors Notes: Lower the thermostat to 40 °F so that the lift station has freeze protection without using excess heating.

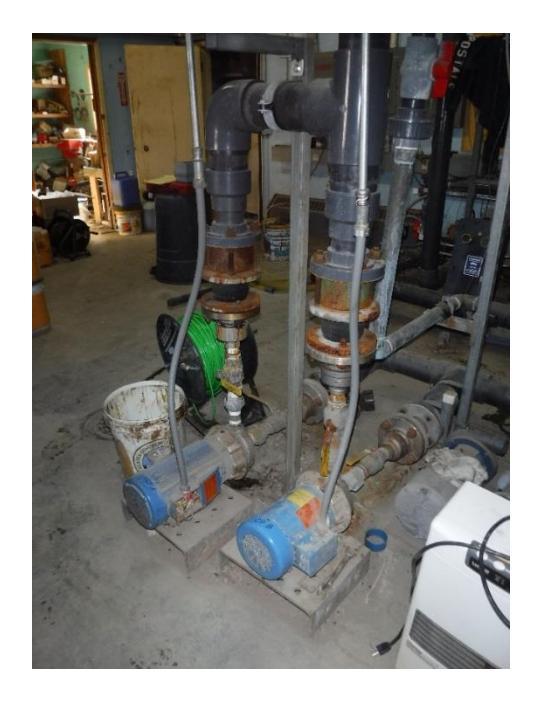
Figure 12: Middle Pump House Circulation Pumps

There are two circulation pumps in the Pump House that are used to pump water from the circulation loop into the building to be heated before going back out to the loop again. This helps keep the loop flowing properly and provides heat to the loop. The pumps must flow constantly in order to adequately supply water for the transfer pumps when needed.

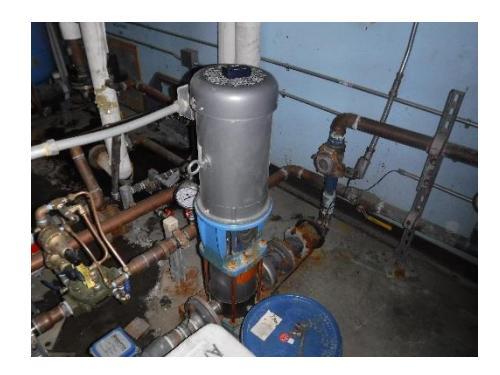
Figure 13: Middle Pump House Transfer Pump

The transfer pump is used to move water from the lower loop to the upper loop. This occurs when the upper loop wells are unable to meet community demand or when the lower loop reaches the maximum allowable pressure for the system and water is transported to the upper loop to relieve the system pressure.

Rank	Location Description of Existing			E	Efficiency Recommendation				
5	Transfer Pur	mp Tr	ransfer Pump	Slow the speed of the pump down to extend the					
				runtime, lower	runtime, lower the amp draw, and reduce the starts				
							and stops of the pump, contributing to a longer		
					lifetime.				
Installation Cost		\$2,000	Estimated Life of Measure (yrs)	1	5 Energy Savings	(\$/yr)	\$841		
Breakev	ven Cost	\$11,268	Simple Payback (yrs)		2 Energy Savings	(MMBTU/yr)	4.2 MMBTU		
			Savings-to-Investment Ratio	5.	.6 Maintenance S	avings (\$/yr)	\$150		
Auditors	Notes: Slow	the speed of the	e pump down to extend the runtime	e and reduce th	ne starts and stops of	of the pump, co	ntributing to a longer		
lifetime.	. This involves	repairs to the m	odulating controls on the VFD syste	em to reduce th	ne RPM's that the p	ump is actively	using. Estimating to		
increase	e pump efficier	ncy by 25% on av	verage based on assumptions from t	the affinity laws	s. Maintenance sav	vings from exter	ided life of the pump

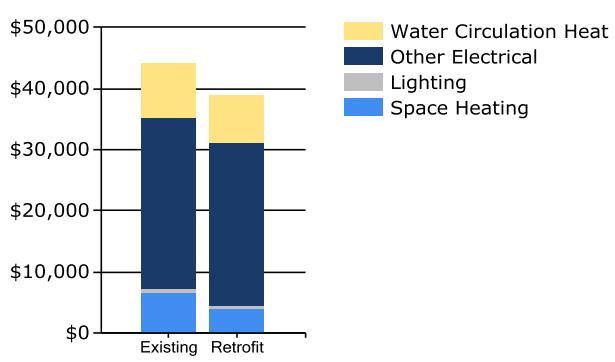
Figure 13: Annual Energy Costs by End Use

Figure 13 below reflects the estimated distribution of costs across the primary end uses of energy based on the AkWarm<sup>©</sup> computer simulation. Comparing the "Retrofit" bar in the figure to the "Existing" bar shows the potential savings from implementing all of the energy efficiency measures shown in this report.

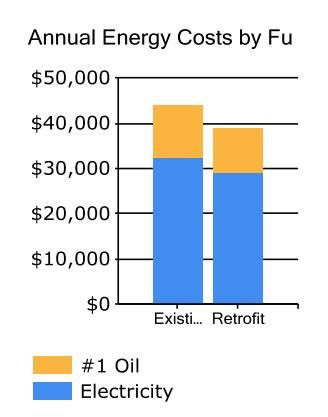
Figure 14: Annual Energy Costs by Fuel Type

Figure 14 below shows how the annual energy cost of the building splits between the different fuels used by the building. The "Existing" bar shows the breakdown for the building as it is now; the "Retrofit" bar shows the predicted costs if all of the energy efficiency measures in this report are implemented.

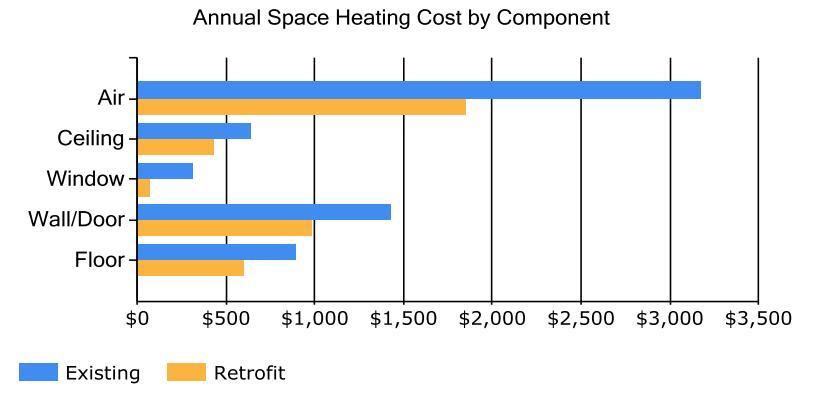
Figure 15: Annual Space Heating Costs

Figure 15 below addresses only space heating costs. The figure shows how each heat loss component contributes to those costs; for example, the figure shows how much annual space heating cost is caused by the heat loss through the Walls/Doors. For each component, the space heating cost for the Existing building is shown (blue bar) and the space heating cost assuming all retrofits are implemented (yellow bar) are shown.

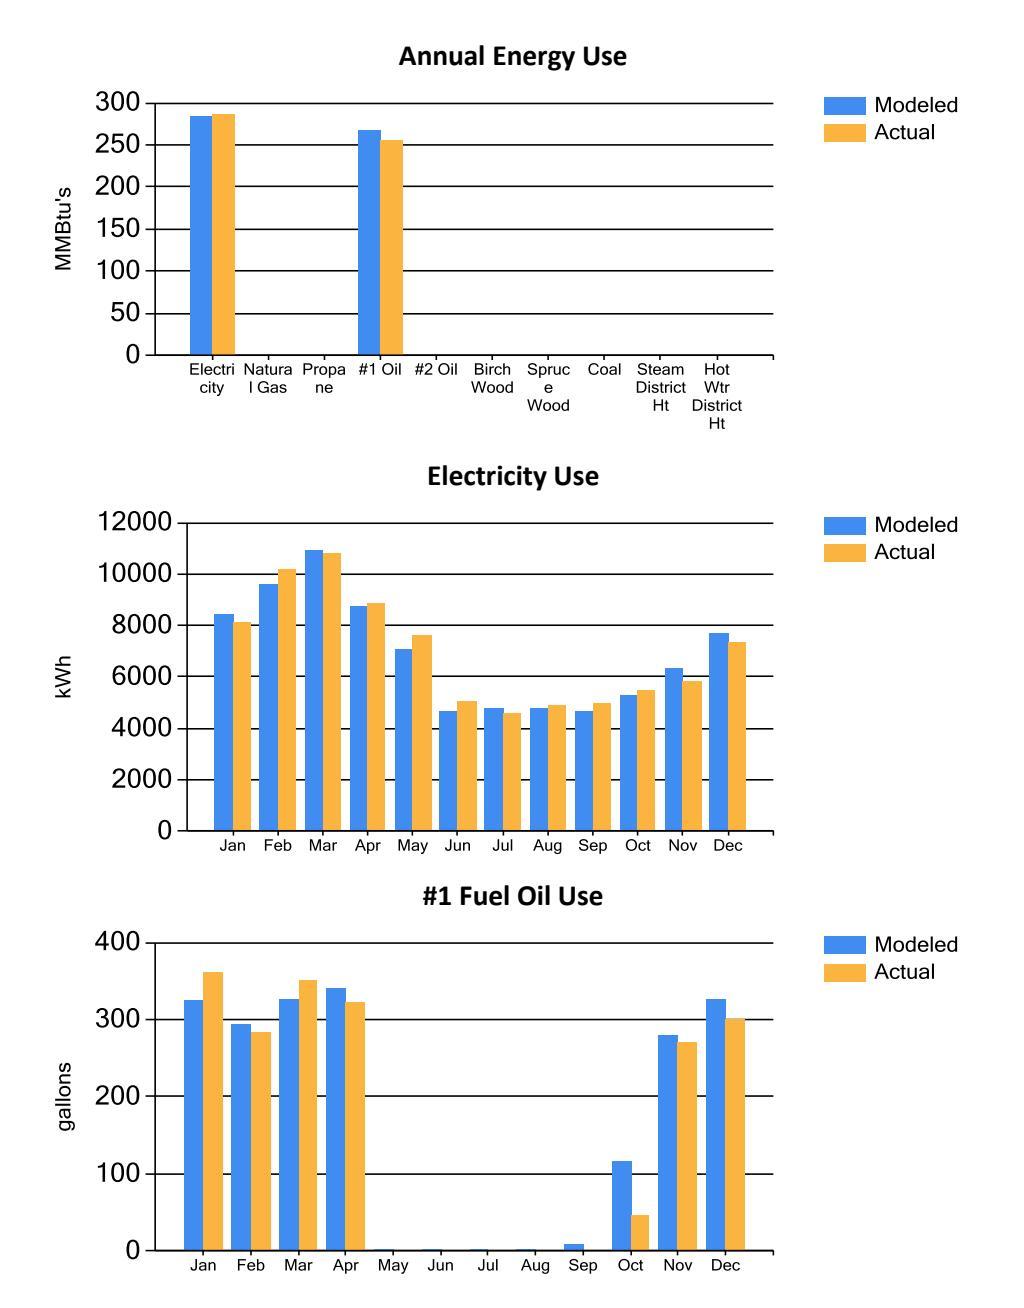
The graphs below show the modeled energy usage results of the energy audit process compared to the actual energy usage report data. The model was completed using AkWarm modeling software. The orange bars show actual fuel use, and the blue bars are AkWarm's prediction of fuel use.
