# Comprehensive Energy Audit For

# **Chistochina VPSO Housing**

Prepared For Cheesh'Na Tribe

March 29, 2019

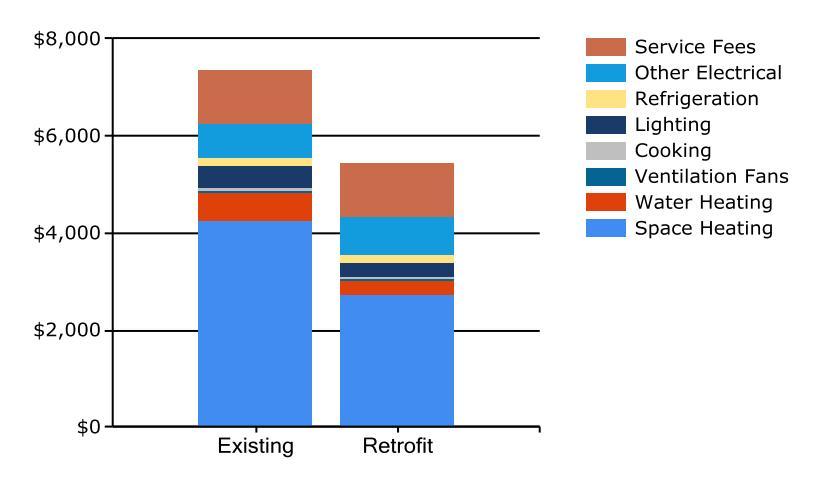
Figure 1.1: Annual energy costs by use before and after EEMs.

Figure 1.1 below reflects the estimated distribution of costs across the primary end uses of energy based on the AkWarm© computer simulation. Comparing the "Retrofit" bar in the figure to the "Existing" bar shows the potential savings from implementing all of the EEMs shown in this report. Figure 1.2 shows the change in fuel usage after the recommended EEMs are installed.

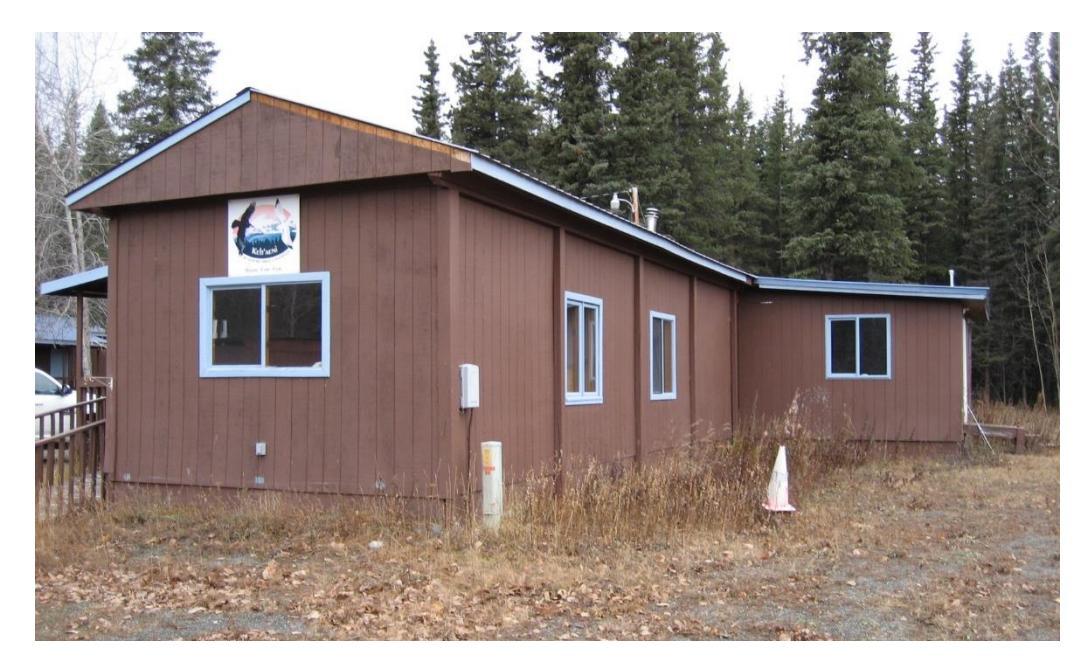
Figure B1. View of the Chistochina VPSO Housing from the road. The addition is to the right of the main part of the building.

Part of the building is a prefabricated mobile home. Mobile homes constructed during the 1980s typically had 2x4, 16" on-center framing with R-13 fiberglass batt insulation in the stud cavity. It was assumed that the addition walls are of similar construction. Due to the building's age, the fiberglass batt in the wall cavity has likely compressed, creating voids in the walls, and may have moisture damage.

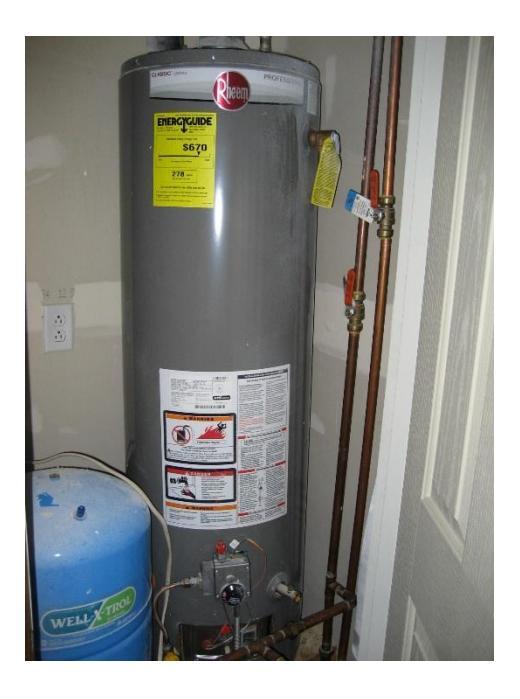
Hot water is produced by a propane-fired, 40-gallon hot water generator. The domestic hot water (DHW) lines were uninsulated and the hot water generator did not have any additional insulation.

Figure B2. Uninsulated DHW plumbing and hot water generator in the VPSO Housing.

Rank	Feature	Improvement Description	Annual Energy Savings	Installed Cost	Savings to Investment Ratio, SIR <sup>1</sup>	Simple Payback (Years) <sup>2</sup>
1	Lighting: Ceiling Mounted Fixtures	Replace all incandescent bulbs with LED equivalents.	\$77 + \$24 Maint. Savings	\$21	40.76	0.2
2	Lighting: Bathroom Vanity	Replace all incandescent bulbs with LED equivalents.	\$92 + \$32 Maint. Savings	\$28	37.40	0.2
3 Thermostat and Temperature Setback		Replace the existing building thermostat with a programmable model. Program the thermostat to maintain the building temperature at 60°-65°F when it is unoccupied.	\$225	\$200	14.91	0.9
4	Trailer Attic Space	Add R-38 fiberglass batt to the attic space.	\$292	\$1,771	3.77	6.1
5	Heating, Ventilation, and Domestic Hot Water	Clean and tune air furnace. Perform an annual efficiency test. Clean the ductwork and add insulation to the ducts. Change air filters. Insulate all DHW plumbing. Install a hot water tank blanket to reduce heat loss.	\$340	\$4,600	2.67	5.0

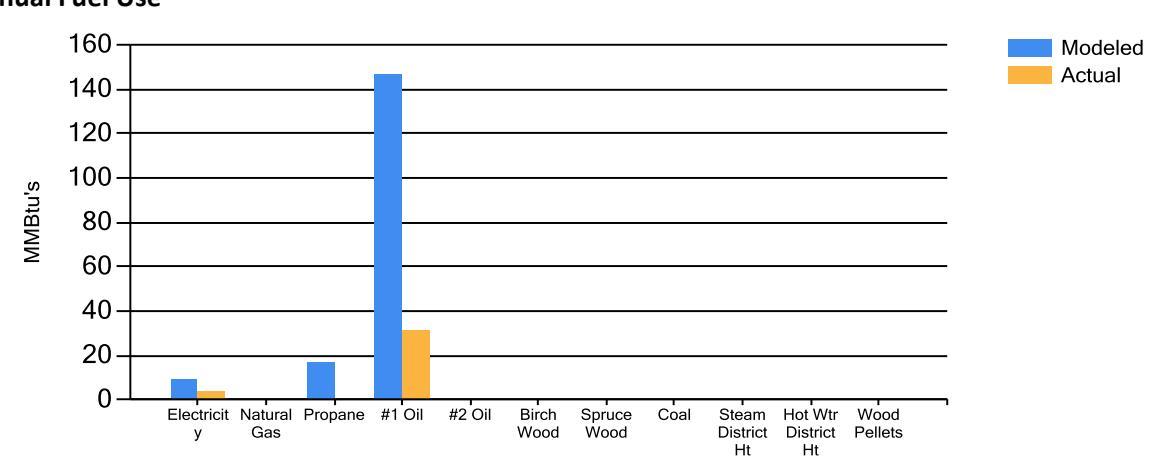
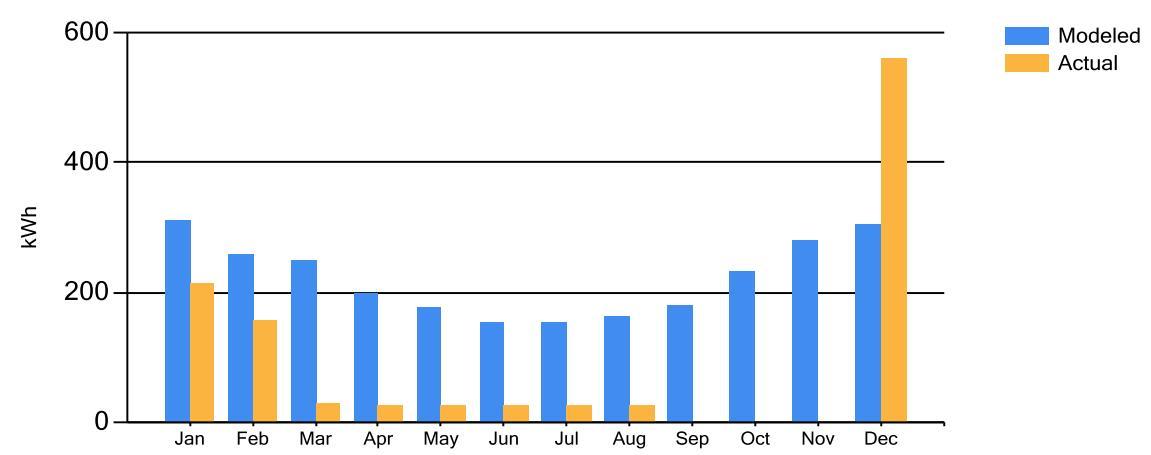
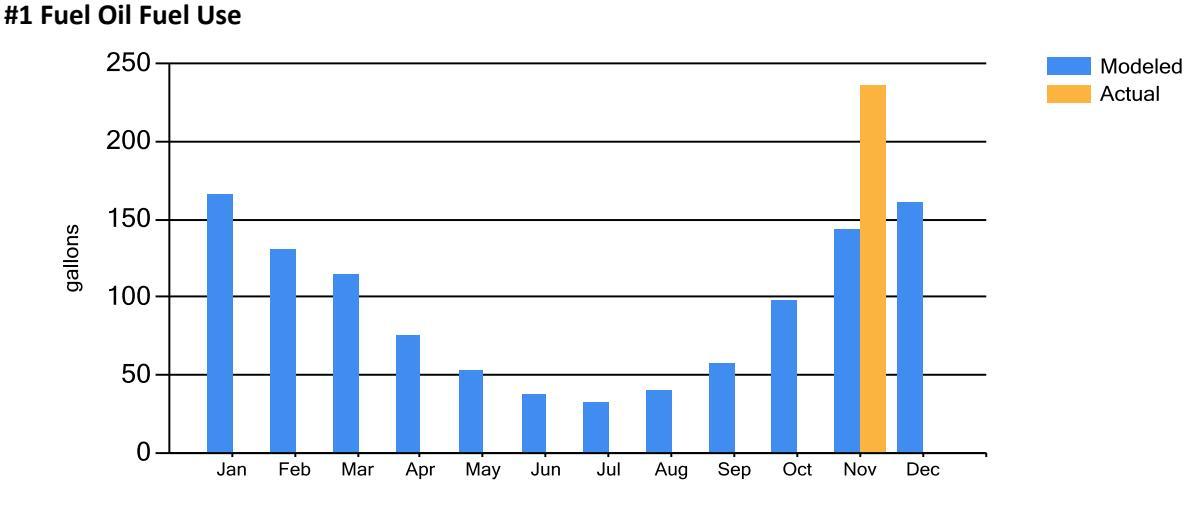
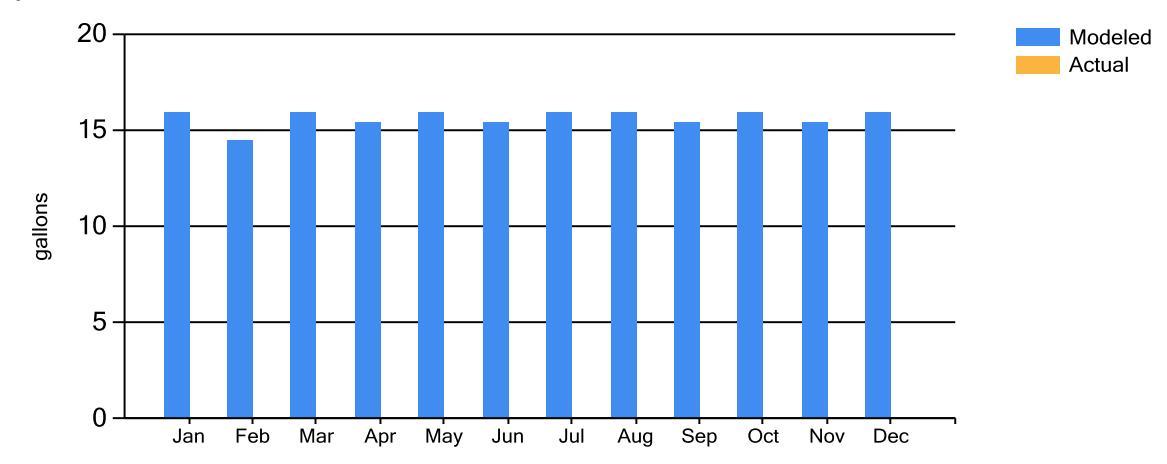
The graphs below show the modeled energy usage results of the energy audit process compared to the actual energy usage report data. The model was completed using AkWarm<sup>©</sup> modeling software. The orange bars show actual fuel use, and the blue bars are AkWarm<sup>©</sup>'s prediction of fuel use.

*Note: The "actual" fuel usage above is by delivery, not the amount used during the month.*

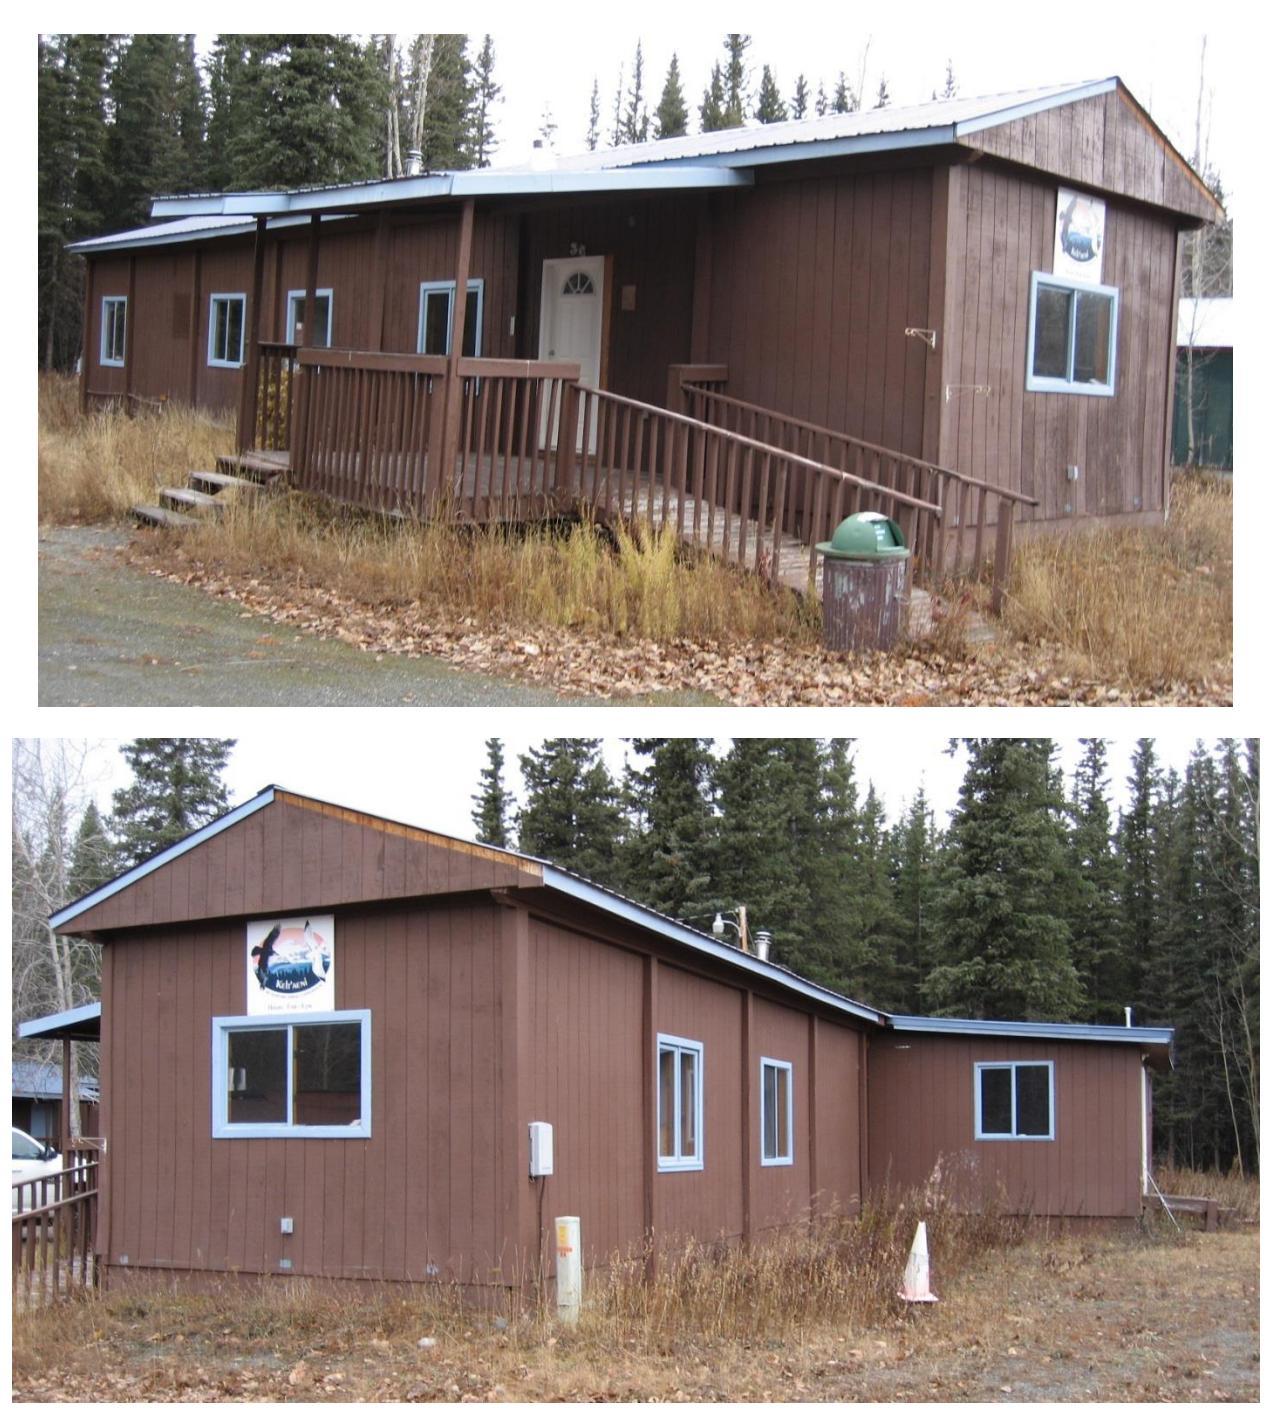
VPSO Housing Exterior.

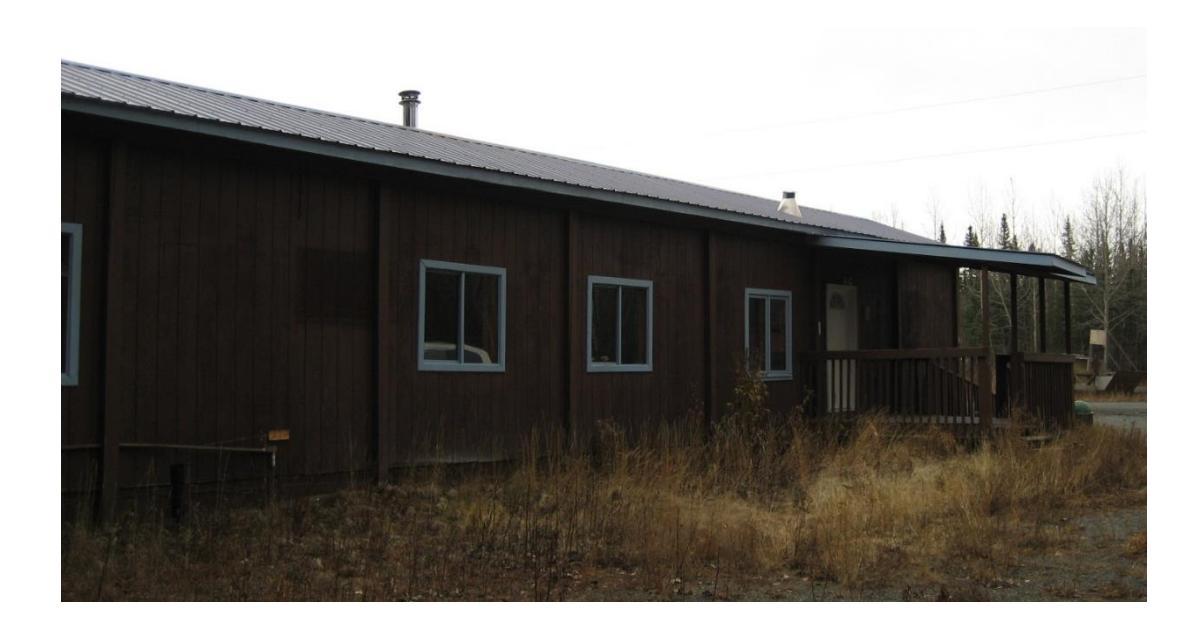
Typical Window.

Consider sealing the windows with plastic shrink-wrap during the winter and installing thermally insulating curtains. Close the curtains when the building is not in use to further reduce heat loss.
